Chatham Islands Surface Water Summary 2022-23

Environment Canterbury Science Summary:

April 2024

R24/1

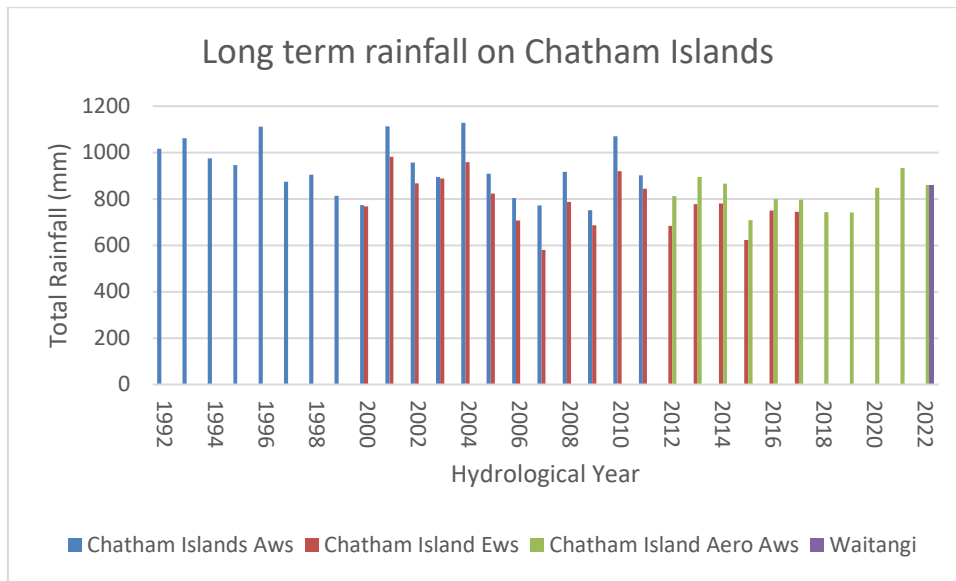
Figure 2-2: Annual rainfall over 1992 – 2022 hydrological years across four recorders in two locations, the Chatham Island airfield and Waitangi

The rainfall at Chatham Islands Aws and Chatham Islands Ews (Waitangi and the Airfield) correlated reasonably well with comparable rainfall in wetter years between 2000 – 2008 (Ritson, 2010). The Chatham Islands Aws and Environment Canterbury’s Waitangi station are recording in the same location and therefore should be correlated similarly (Figure 2-2, Figure 2-3).

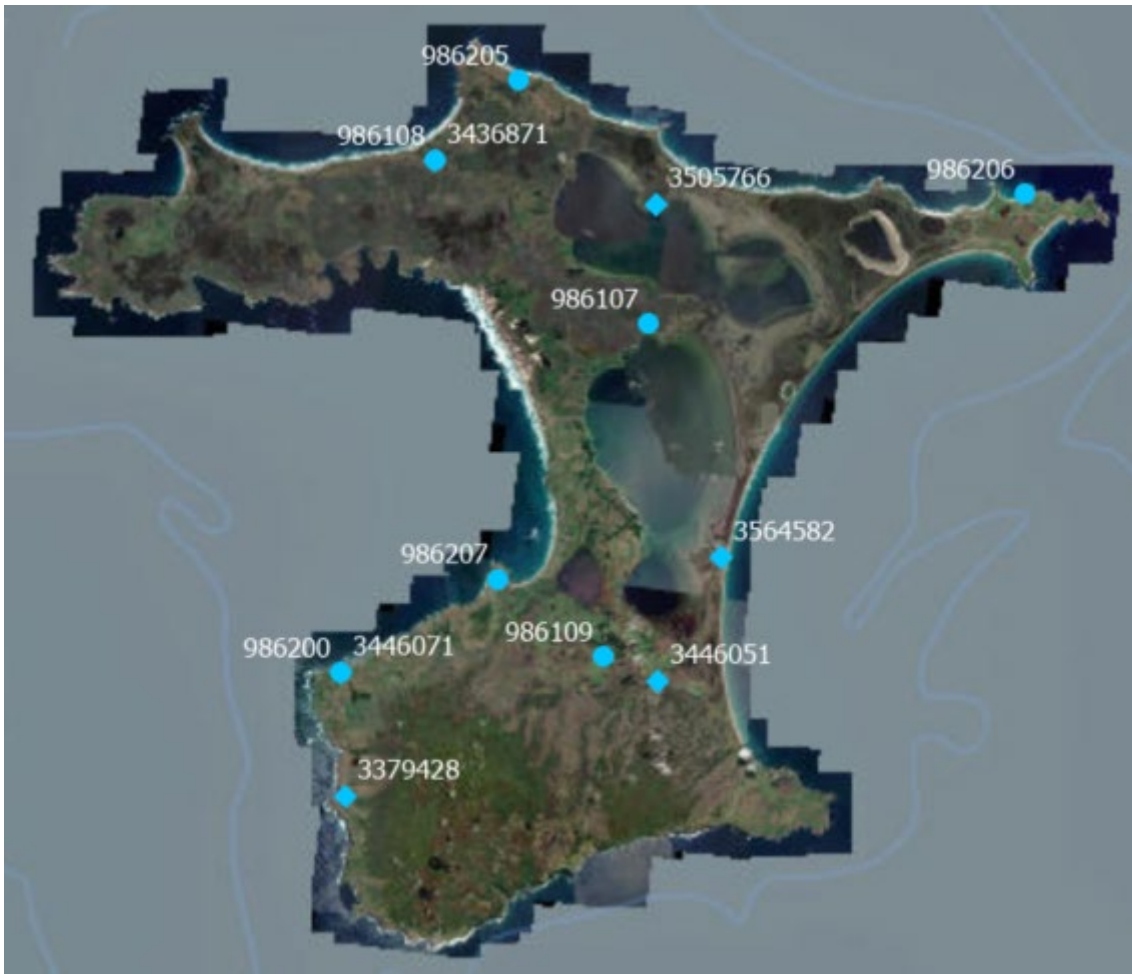
Figure 2-3: Chatham Island water flow (river) and level (lagoon) and rainfall recorders. Rainfall sites are indicated as circles and water level recorders are indicated as diamonds

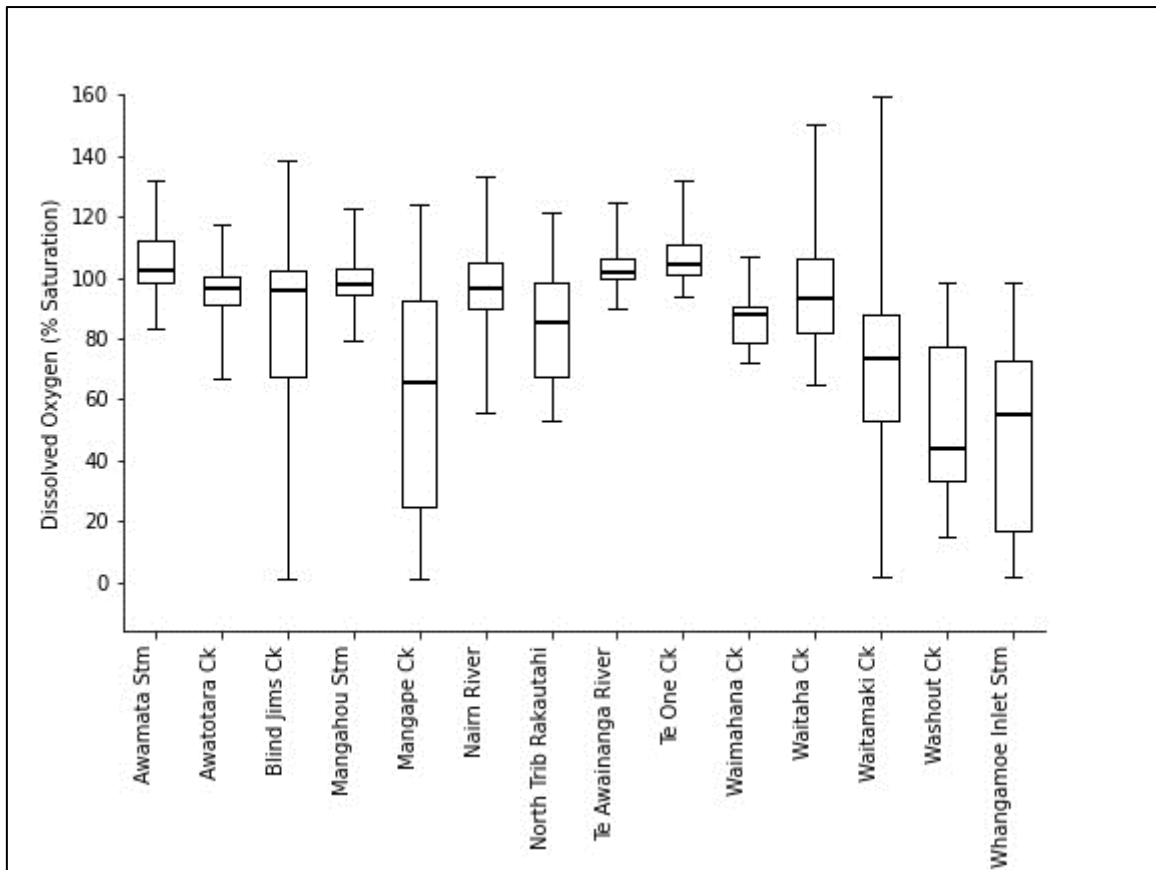
Figure 3-1: Current state of dissolved oxygen for monitored river sites on Chatham Island

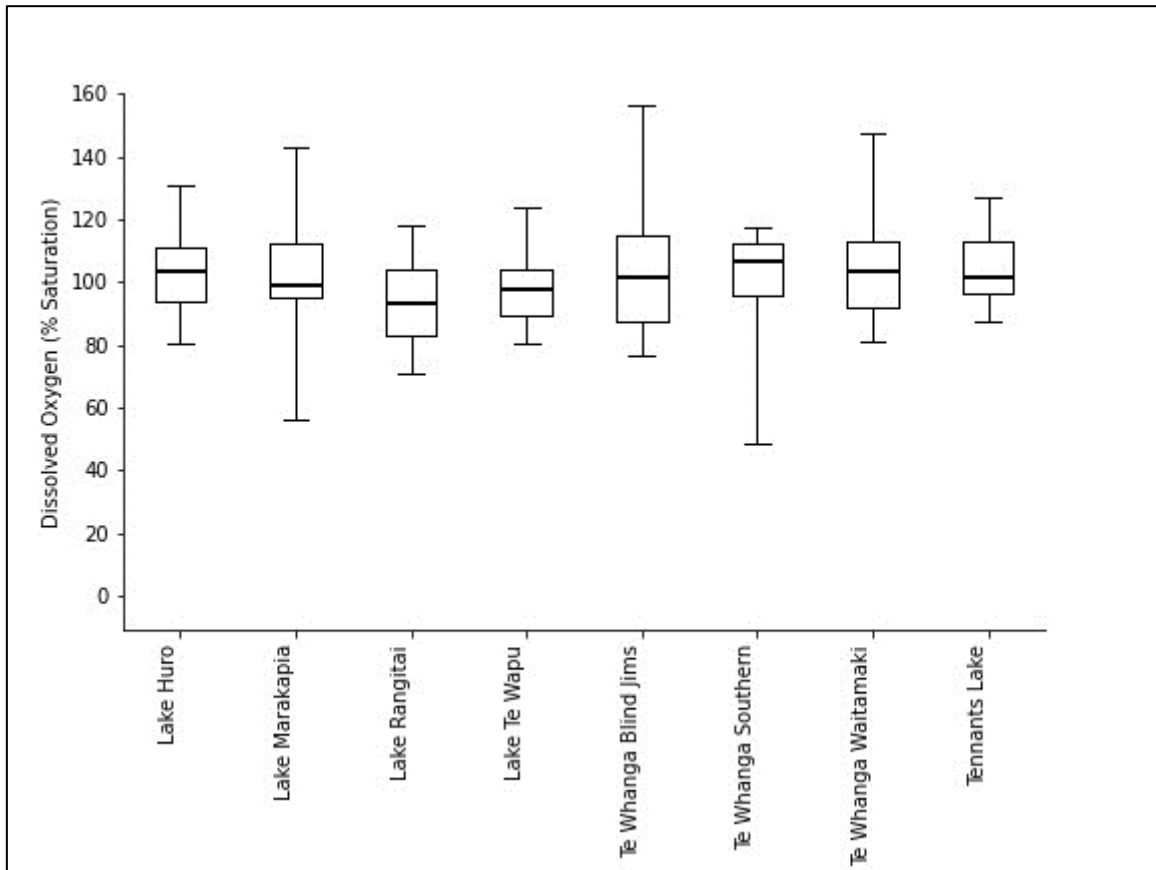
Figure 3-2: Current state of dissolved oxygen for monitored lake sites on Chatham Island

Sites in Te Whanga lagoon at Blind Jims and Waitamaki both showed a high range of dissolved oxygen and on occasion were above 150% saturation (Figure 3-2). This indicates a likely high algal biomass with high oxygen generation in daylight (photosynthesis) and lower concentrations (respiration) at night. These likely reflect a degree of increased eutrophication.

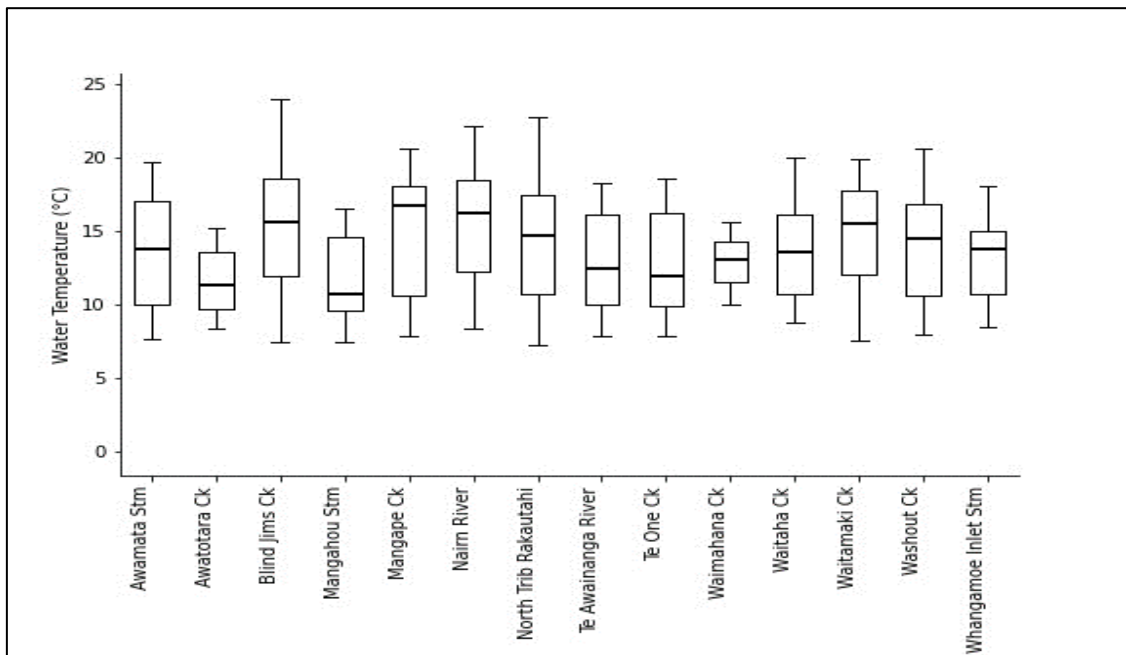
Figure 3-3: Current state of water temperature for monitored river sites on Chatham Island

Water temperature in both Chatham Island streams (Figure 3-3) and lakes (Figure 3-4) are stable with limited variation (generally 8-20°C) and an absence of extreme temperatures that would be harmful to aquatic life. This is because waterways are probably thermally buffered by both the maritime climate and proximity to the sea, and the high volume of thermally buffered peat and shallow groundwater sources. Water temperature extremes are unlikely to be a significant management issue.

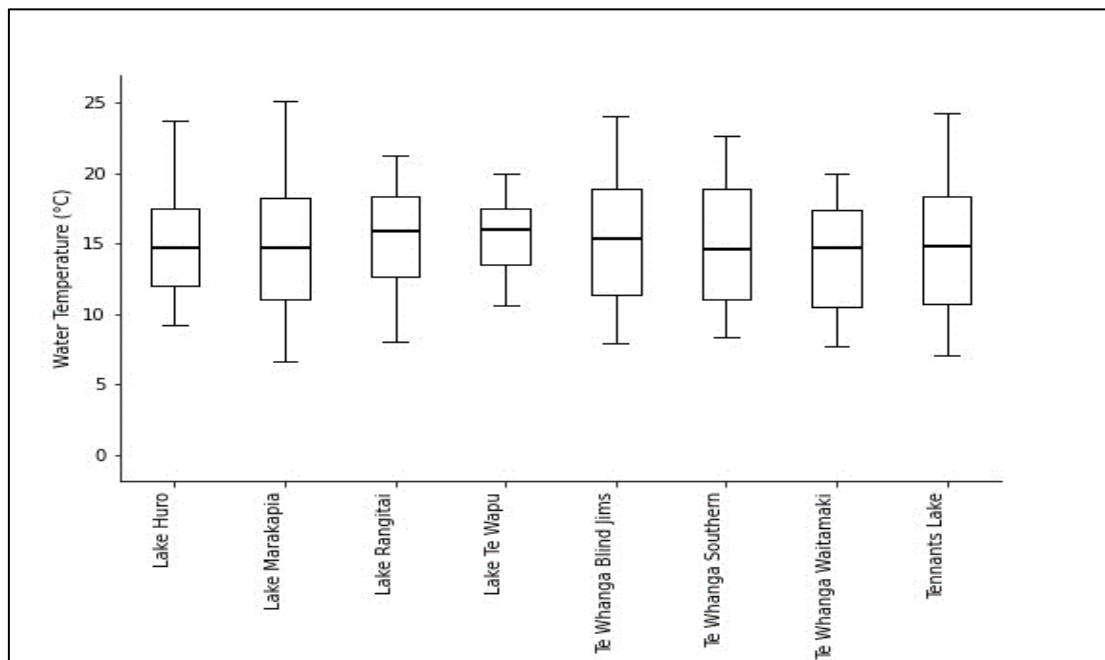
Figure 3-4: Current state of water temperature for monitored lake sites on Chatham Island

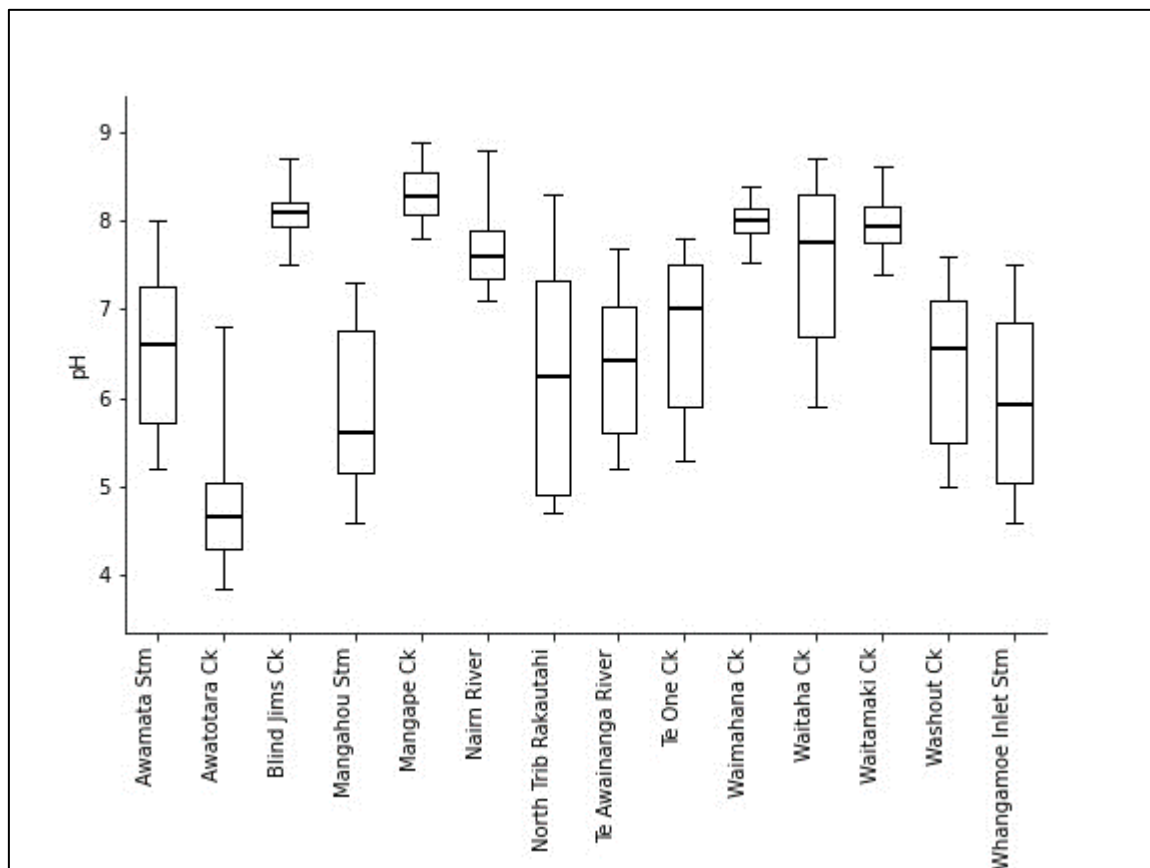
Figure 3-5: Current state of pH for monitored river sites on Chatham Island

The pH of Chatham streams vary greatly with some waterways strongly acidic (pH 4-5) and others alkaline (>8) (Figure 3-5). Many show a high variation (i.e. from pH 5 to 8) which shows many sites may be poorly or not strongly buffered. These results indicate the highly variable geology and nature of catchments that can vary greatly under different discharge conditions. However, despite such variability, the variable pH status may not affect the current low potable or economic use of these surface water resources. In contrast the Chatham Island lake sites have largely alkaline water (pH 8-9) (Figure 3-6).

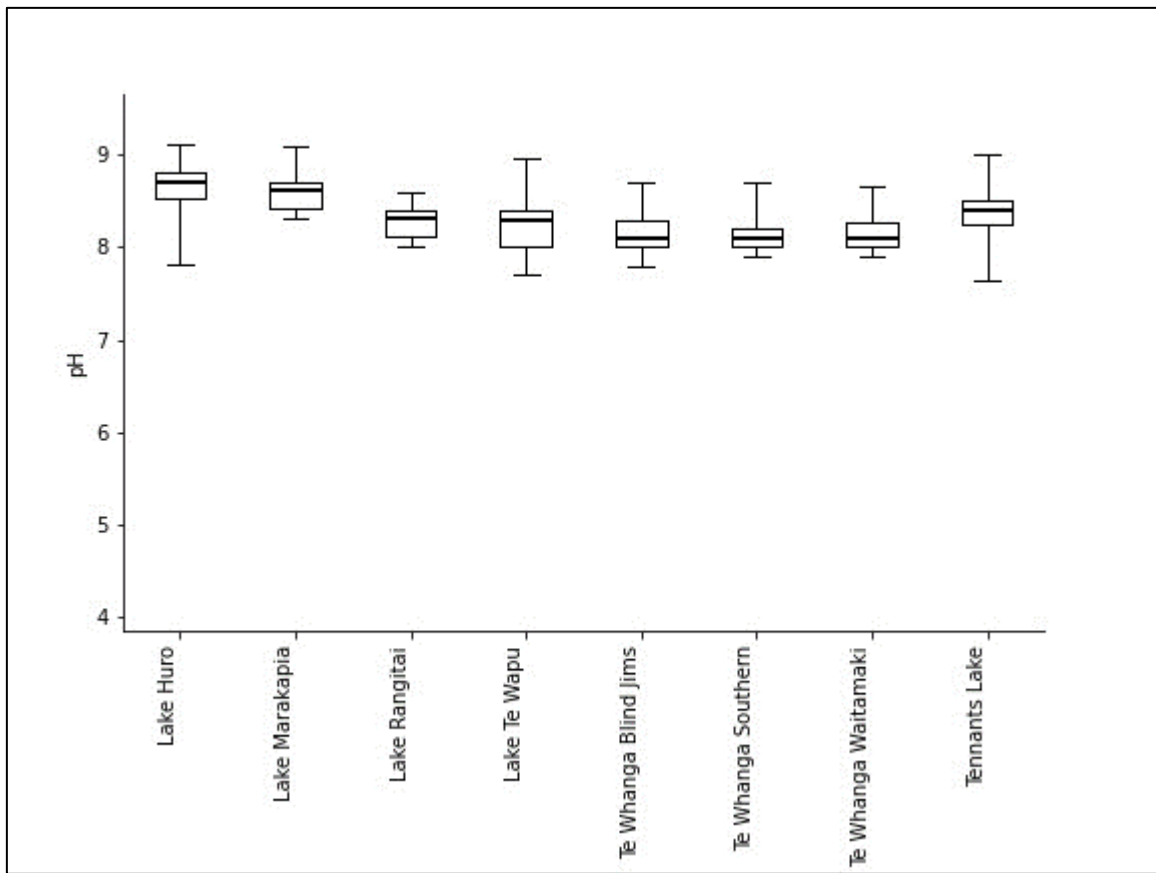
Figure 3-6: Current state of pH for monitored lake sites on Chatham Island

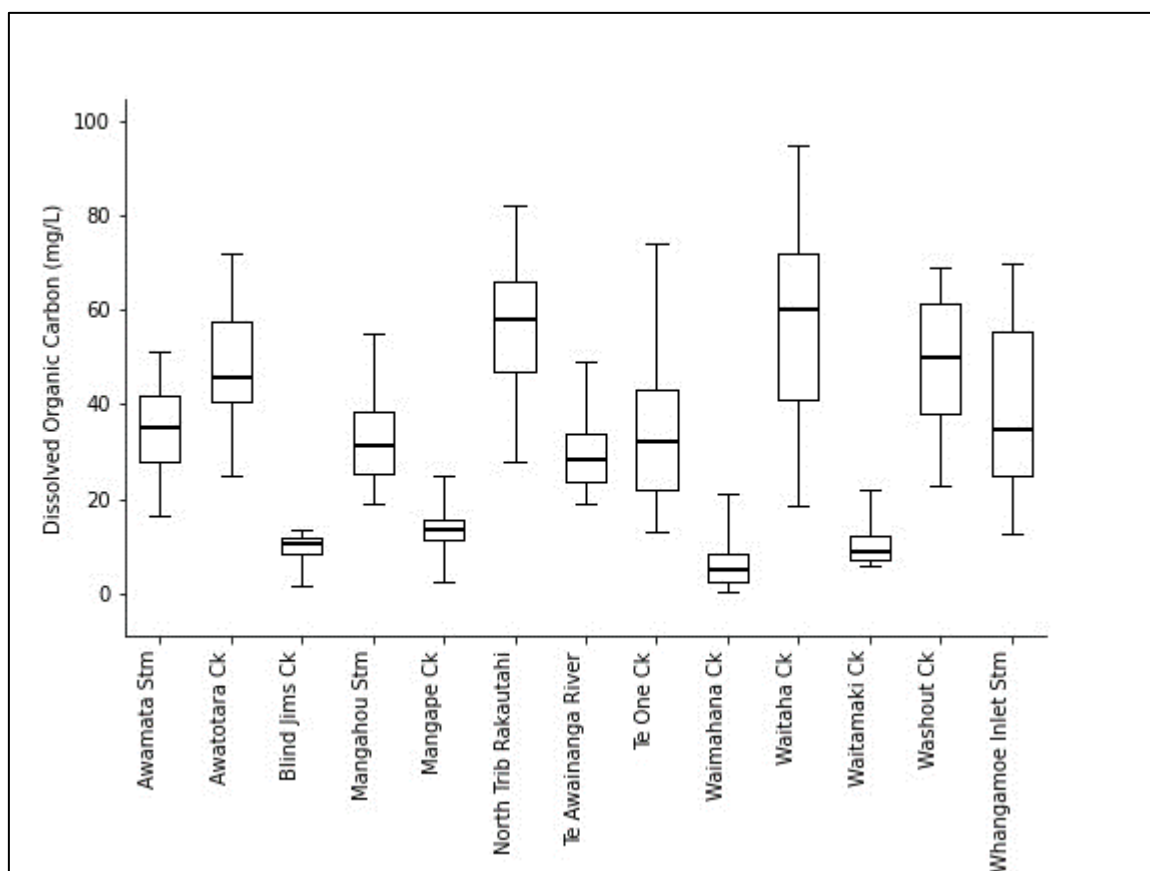
Figure 3-7: Current state of DOC for monitored river sites on Chatham Island

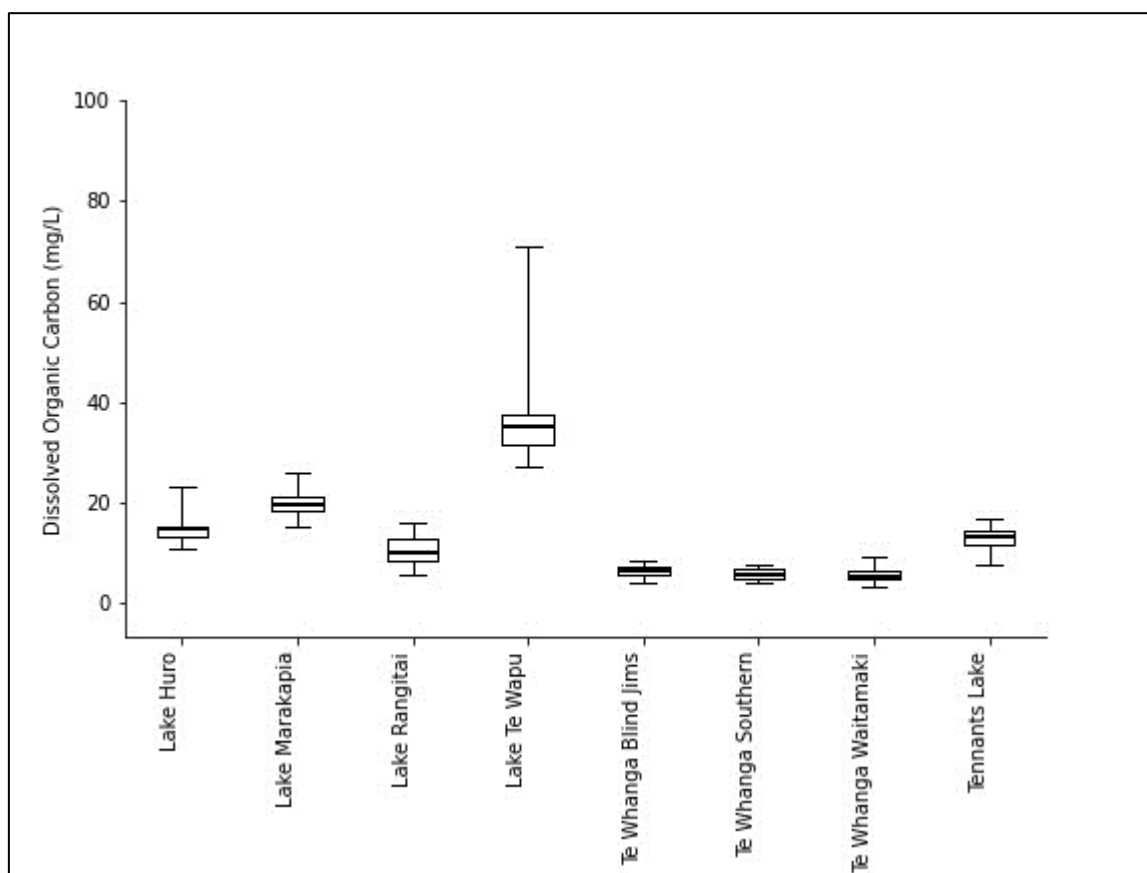
Figure 3-8: Current state of DOC for monitored lake sites on Chatham Island

The lakes had lower DOC but were still elevated compared to most mainland NZ lakes with significant DOC concentrations (Figure 3-8). Lake Te Wapu was the only highly peat stained lake currently in the monitoring program.

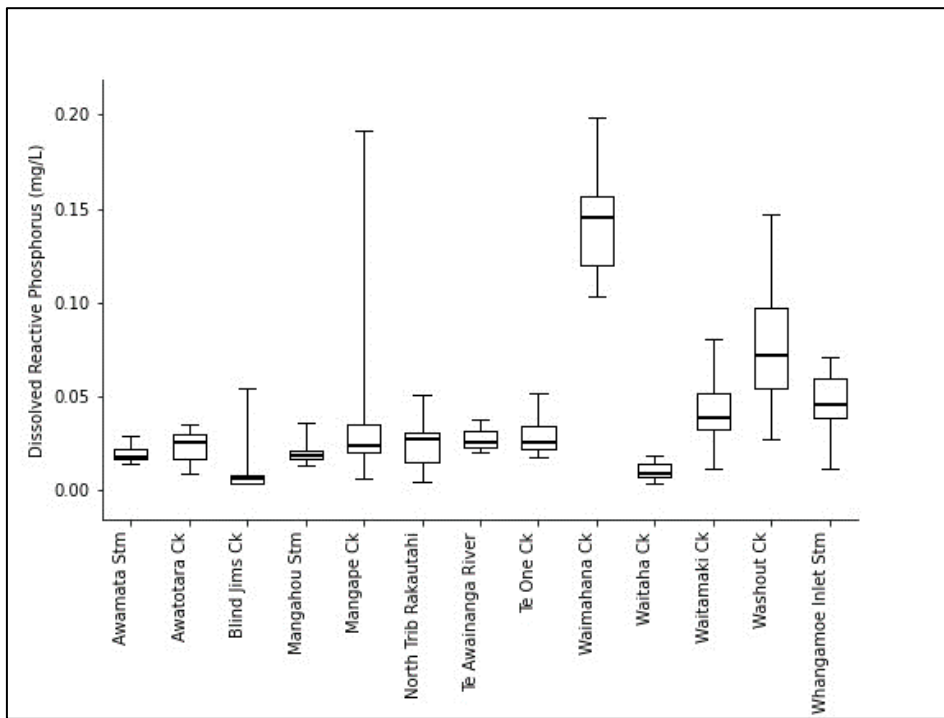
Figure 3-9: Current state of DRP for monitored river sites on Chatham Island

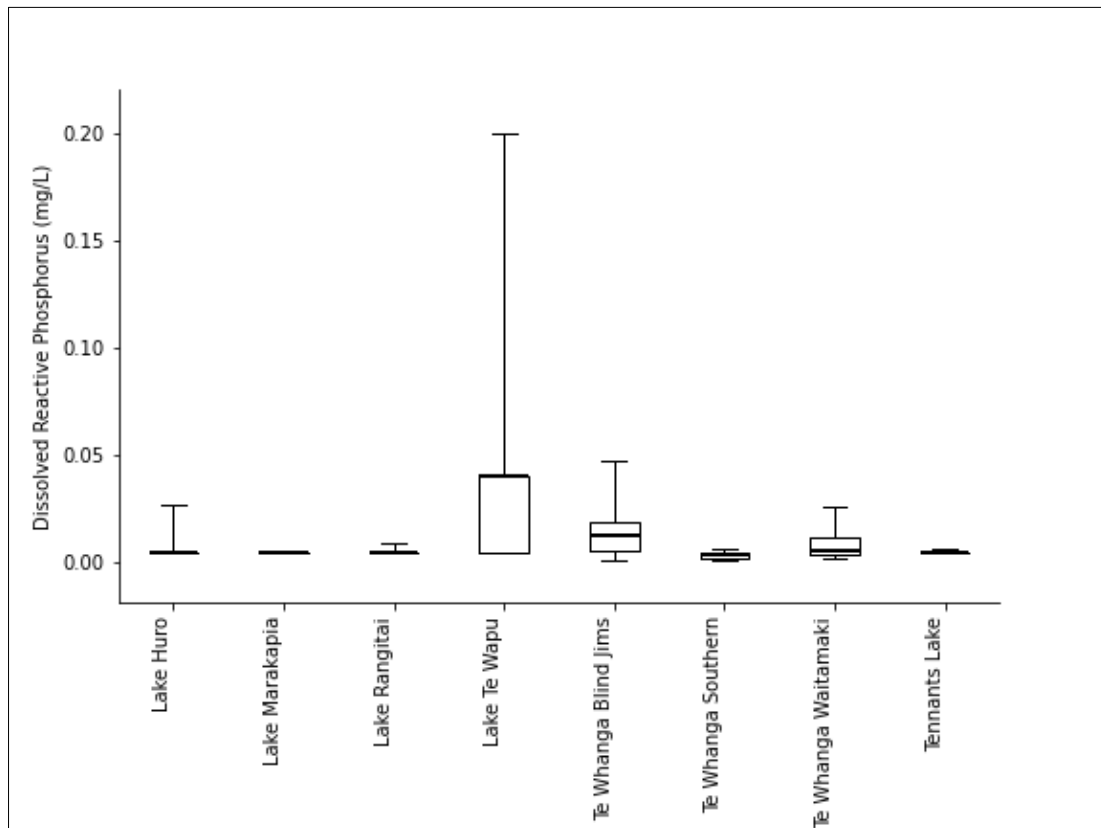
Figure 3-10: Current state of DRP for monitored lake sites on the Chatham Islands

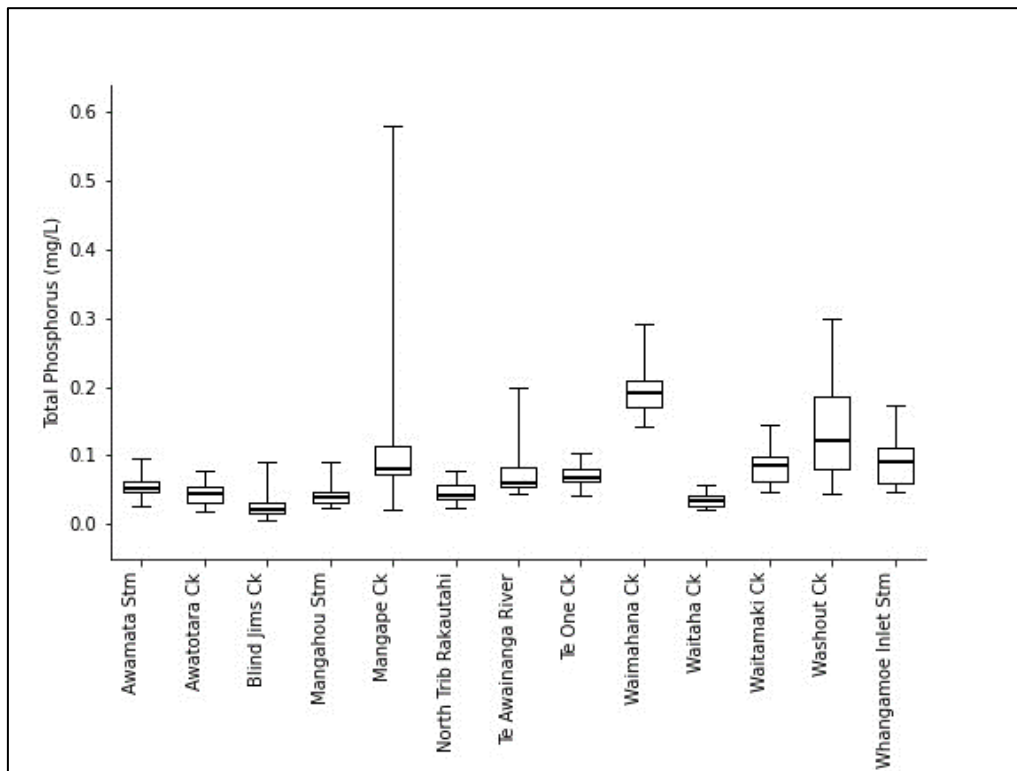
Figure 3-11: Current state of TP for monitored river sites on Chatham Island

Total Phosphorus concentrations (TP) was more variable, possibly reflected by the phosphorus content in suspended peat particles and was higher in streams than lakes (Figure 3-11, Figure 3-12).

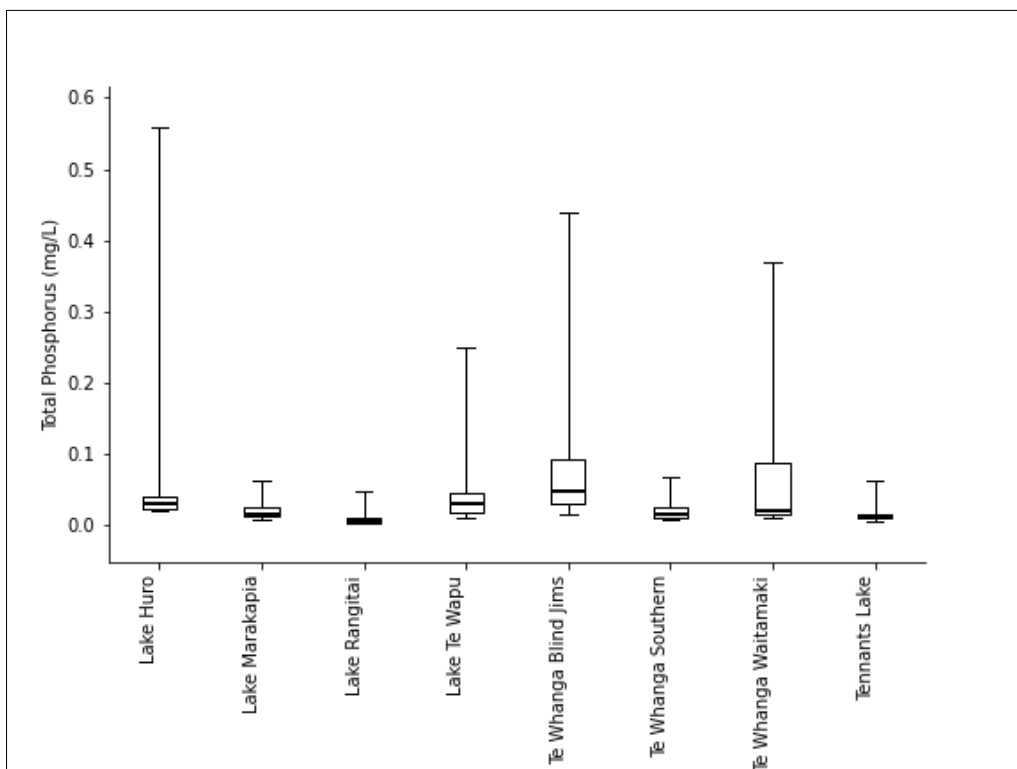
Figure 3-12: Current state of TP for monitored lake sites on Chatham Island

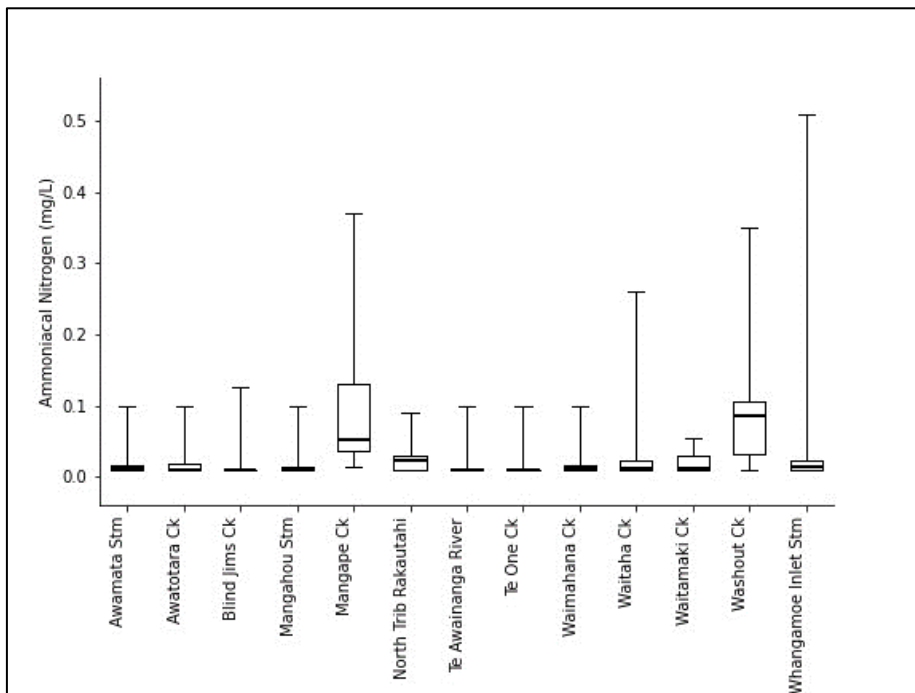
Figure 3-13: Current state of NH_4N for monitored streams on Chatham Island

Nitrogen concentrations are expected to be low on Chatham Island because nitrogen is generally derived from animal and human inputs rather than from natural geology. Ammoniacal nitrogen (NH_4N) concentrations are very low/absent except from Mangapē and Washout Creeks (Figure 3-13). These likely originate from increased animal or bird faecal and urinary sources of nitrogen. Lakes are more variable in ammonia concentrations (Figure 3-14).

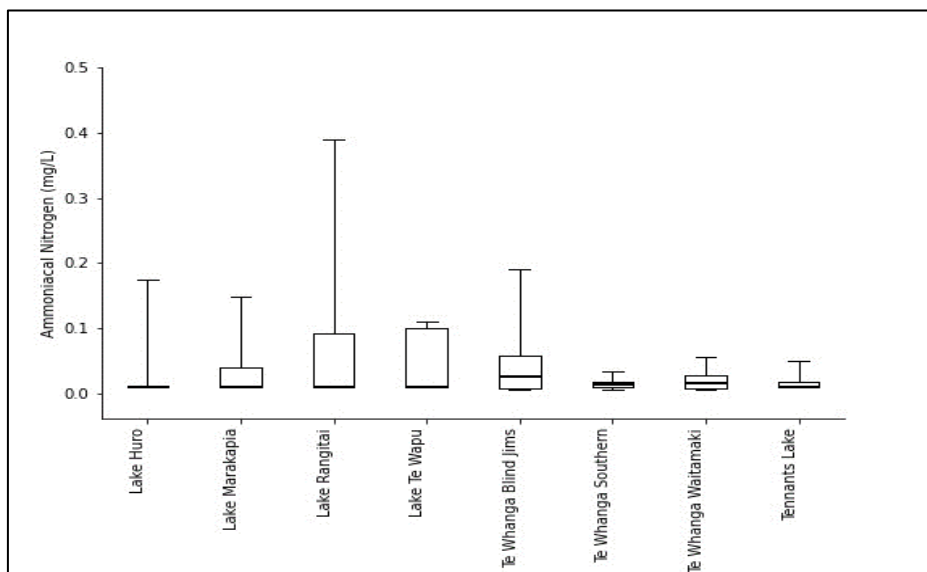
Figure 3-14: Current state of NH_4N for monitored lake sites on Chatham Island

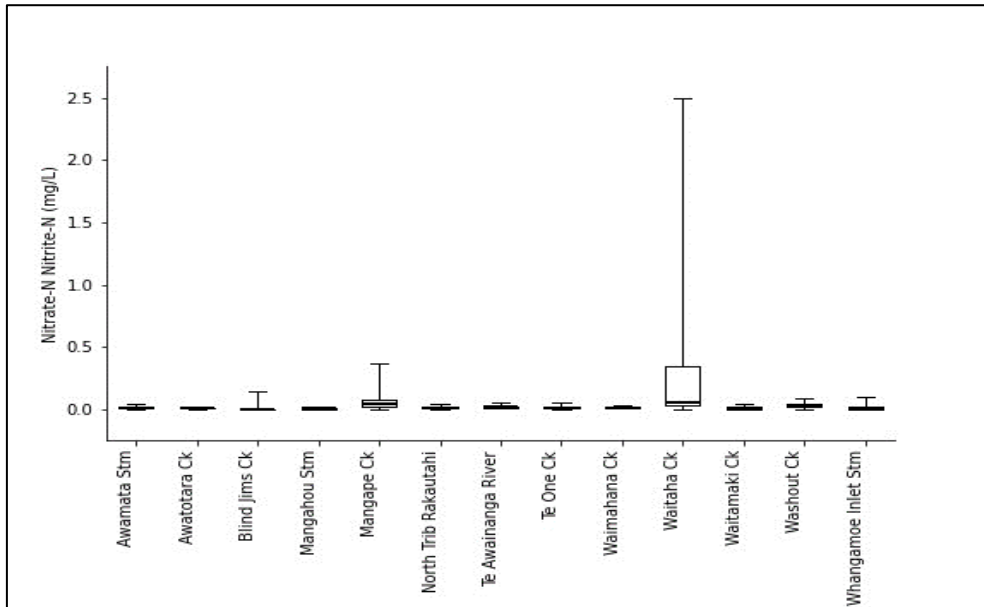
Figure 3-15: Current state of NNN for monitored river sites on Chatham Island

Nitrate-Nitrite nitrogen (NNN) concentrations are very low in both streams and lakes (Figure 3-15, Figure 3-16). Sites with any appreciable NNN indicate a warning for excessive animal derived inputs (Mangapē and Waitaha Streams). Lakes are also low in NNN except for Te Whanga adjacent to Blind Jims Creek. Corresponding Dissolved Inorganic Nitrogen (DIN; ammonia+NNN) as a measure of available dissolved nitrogen is also low in both streams and lakes (Figures 3-17, Figure 3-18).

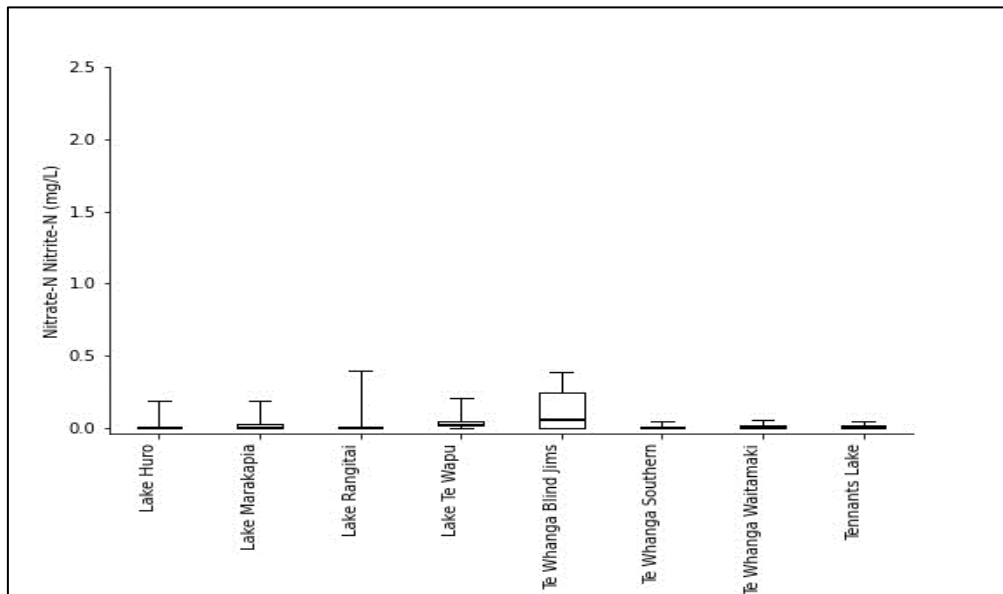
Figure 3-16: Current state of NNN for monitored lake sites on Chatham Island

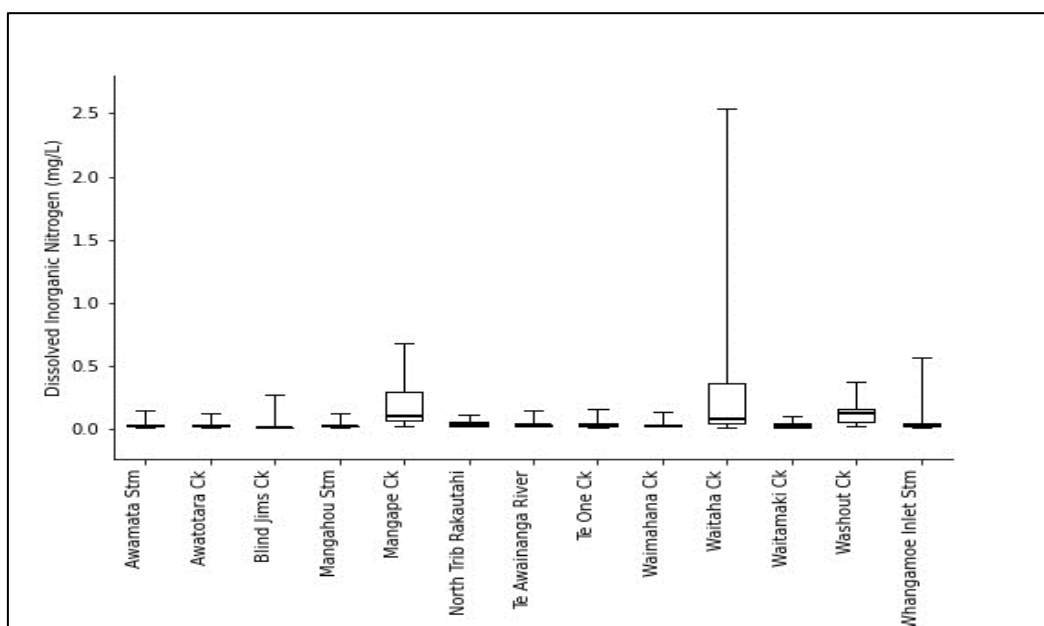
Figure 3-17: Current state of DIN for monitored river sites on Chatham Island

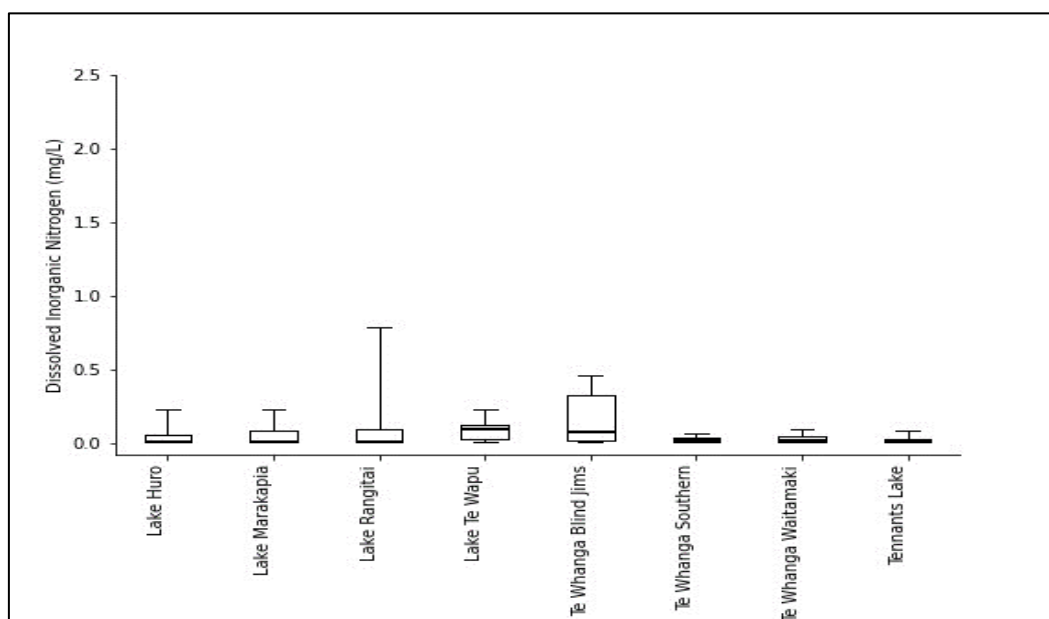
Figure 3-18: Current state of DIN for monitored lake sites on Chatham Island

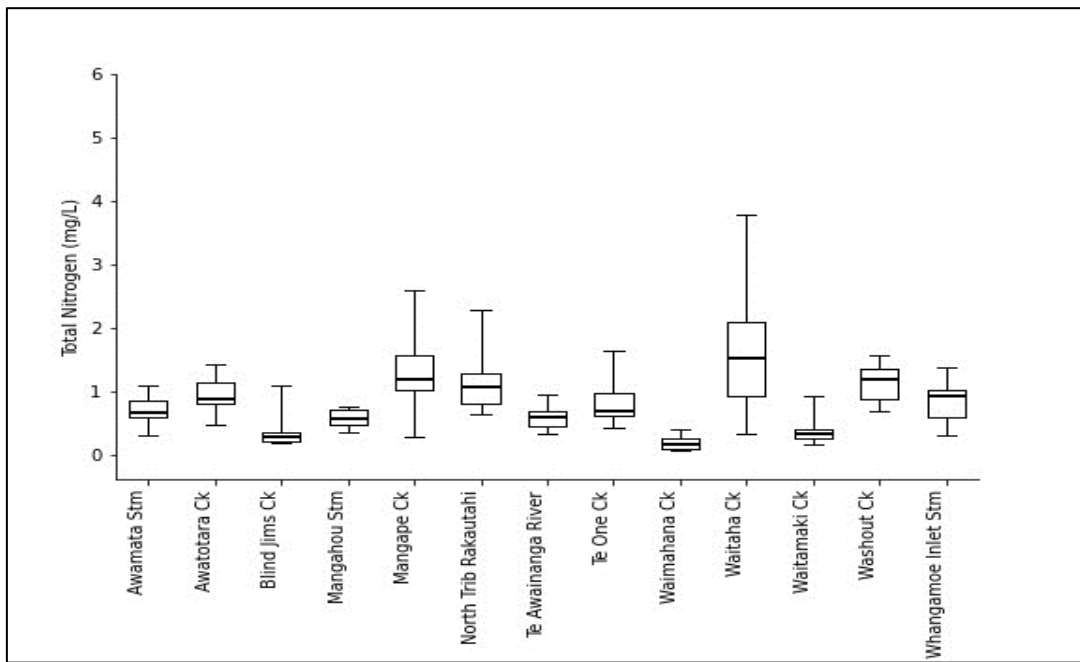
Figure 3-19: Current state of TN for monitored river sites on Chatham Island

Total nitrogen (TN) concentrations reflect the additional nitrogen concentrations in particulate effluent or algal biomass. The TN of streams is surprisingly high, but this likely reflects the nitrogen content of suspended peat particles (Figure 3-19). Other streams such as Mangapē may also reflect algal biomass as fed from Lake Huro. Lakes have similar TN concentrations but may represent either nitrogen in peat particles or in algal biomass or both (Figure 3-20). Lake Huro and Lake Te Wapu show the greatest peak TN concentrations and the greatest variation in concentrations indicating possible episodes of algal blooms.

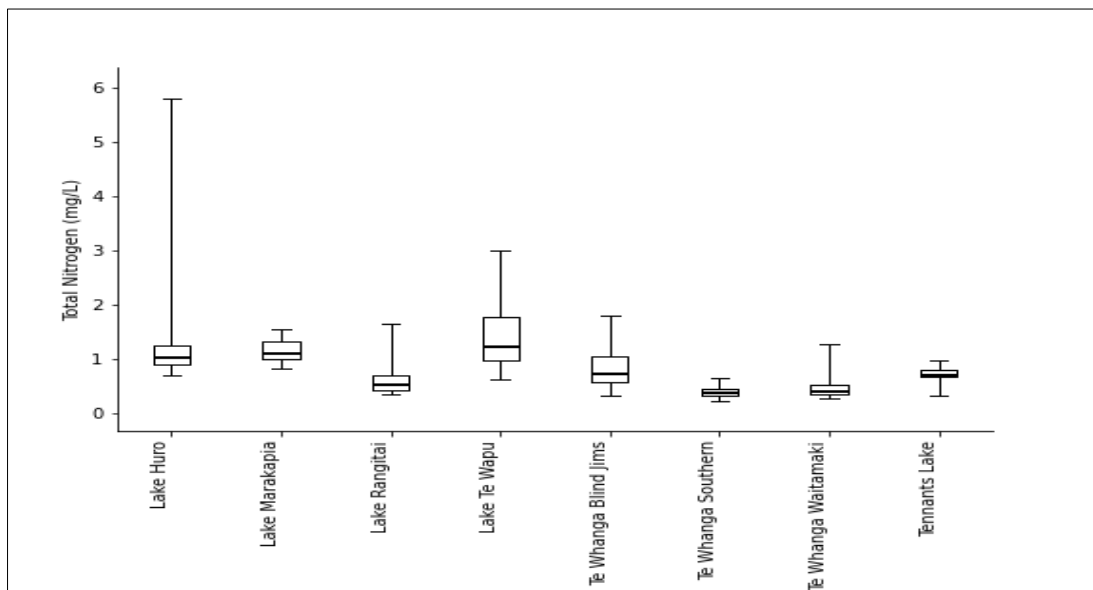
Figure 3-20: Current state of TN for monitored lake sites on Chatham Island

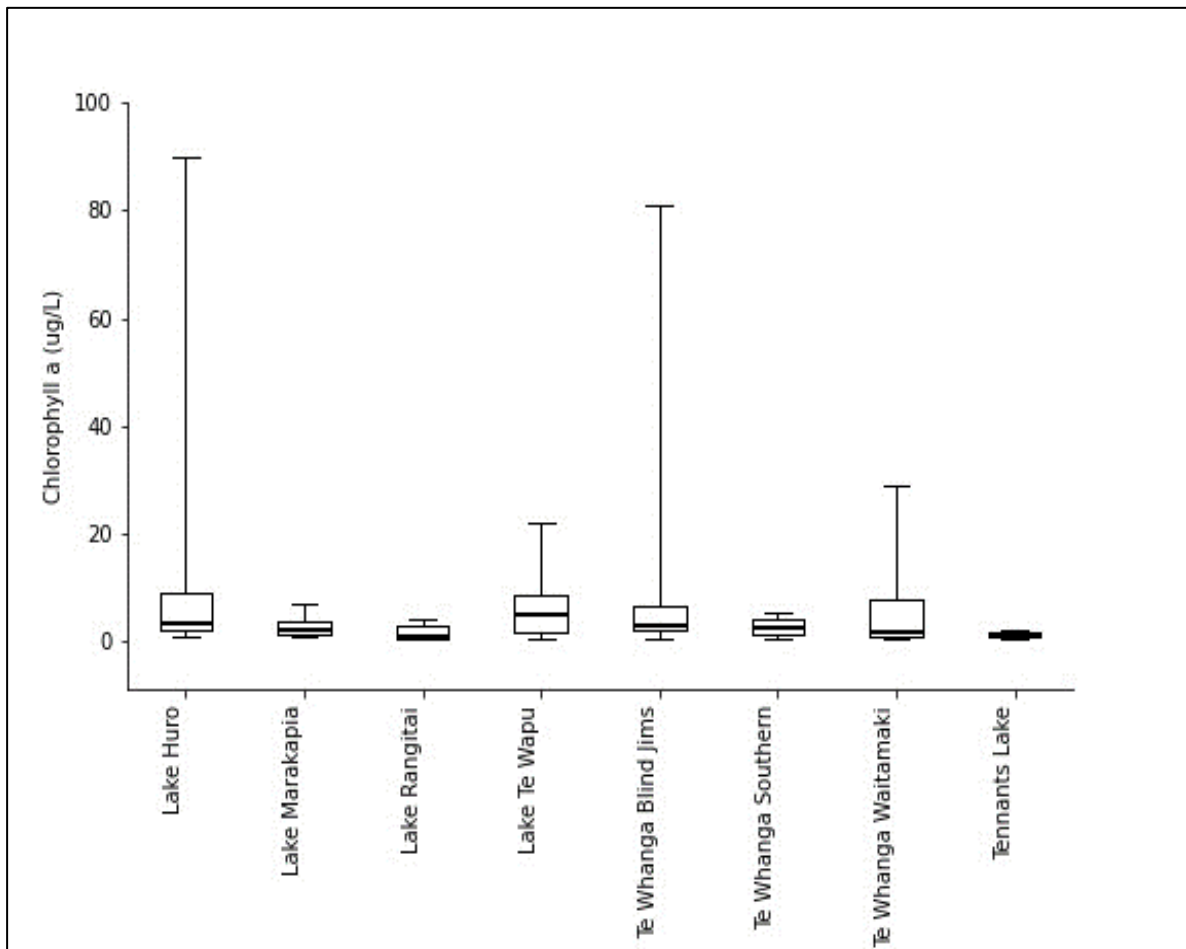
Figure 3-21: Current state of chlorophyll a for monitored lake sites on Chatham Island

Chlorophyll a (Chl a) is an indicator of the algal biomass in the water column of lakes by specifically measuring the chlorophyll pigments present. High Chlorophyll a concentration indicates existing or developing algal blooms. Lake Huro and Te Wapu show significant variation in concentrations indicating annual variations and possible episodes of algal blooms. The two northern Te Whanga lagoon sites also show a higher level of variation also indicating annual variations and possible episodes of algal blooms in the northern lagoon.

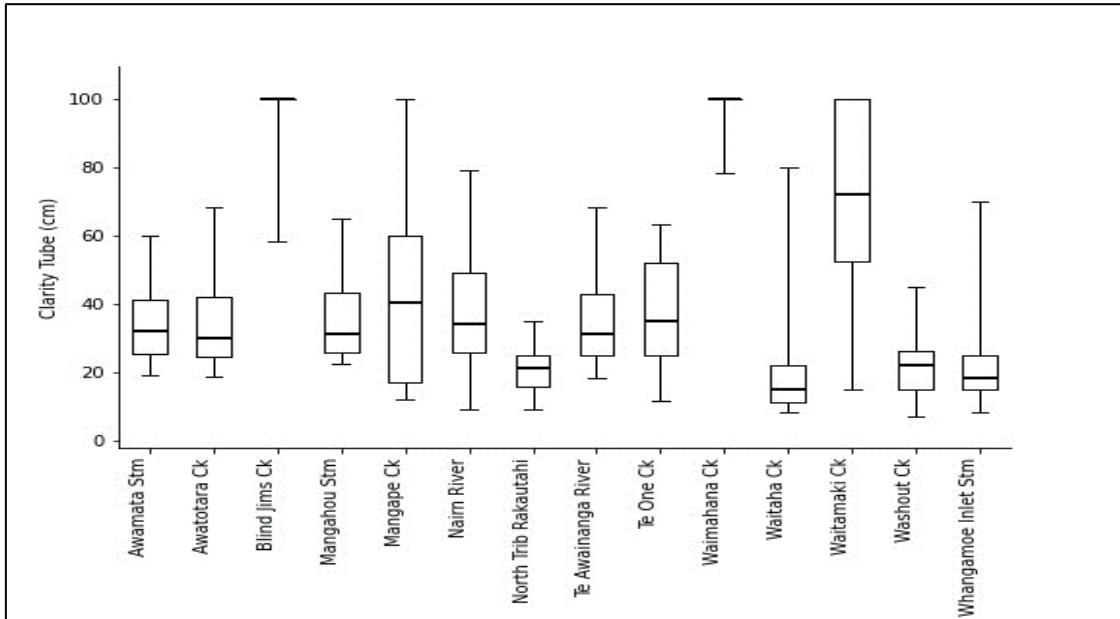
Figure 3-22: Current state of water clarity for monitored river sites on Chatham Island

Water clarity is measured with the SHMAK (Stream Health and Monitoring Action Kit) clarity tube, and high values indicate clear water with high transparency, while low values indicate cloudy or turbid water. Two streams have particularly high clarity compared to the other streams (Blind Jims and Waimāhana streams) while clarity in the other streams are highly variable and can often be very poor (Figure 3-22). This is mostly related to peat staining and peat particles in the water reducing clarity.

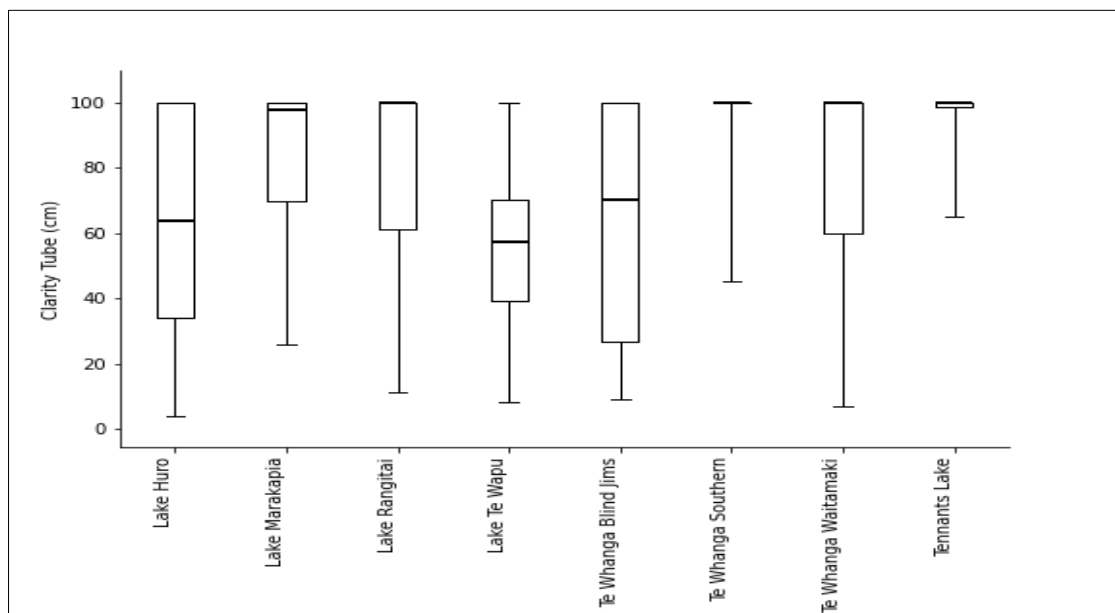
Figure 3-23: Current state of water clarity for monitored lake sites on Chatham Island

The monitored lakes have higher but highly variable water clarity than the streams, although both Lakes Huro and Te Wapu stand out as having lower or degraded water clarity (Figure 3-23).

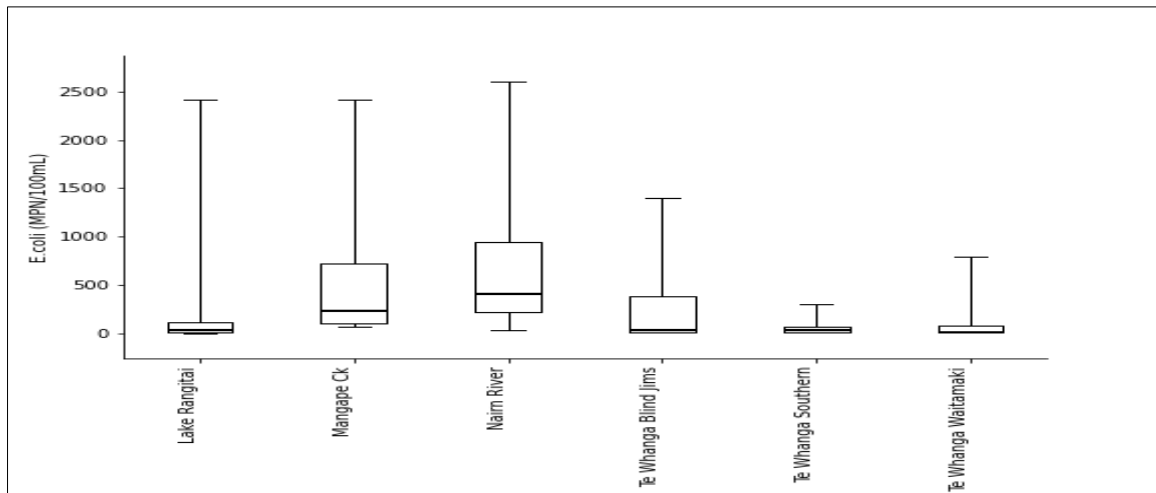
Figure 3-24: Current state of *E. coli* for monitored river and lake sites on Chatham Island

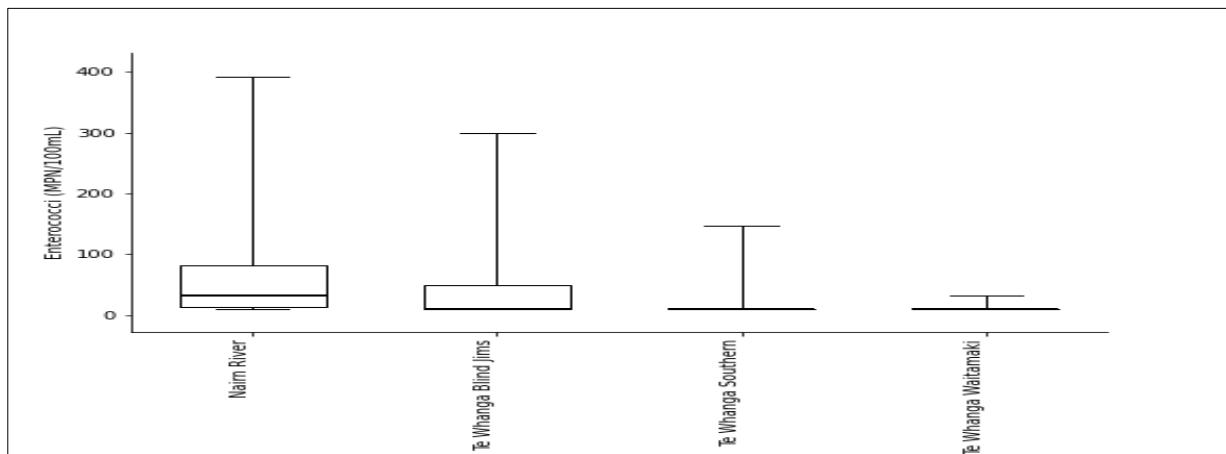
Figure 3-25: Current state of enterococci for monitored river and lake sites on Chatham Island

For the Te Whanga Lagoon sites, the Northern (Blind Jims) site shows the highest degree of variability and median contamination of bacteria. This accompanies the high trophic state and other contaminants alongside this recognised beach and recreation area. For sites with a significant brackish/saline water quality, Enterococci indicators show similar patterns to E. coli. (Figure 3-25).
