Chatham Islands Surface Water Summary 2022-23

Environment Canterbury Science Summary:

April 2024

R24/1

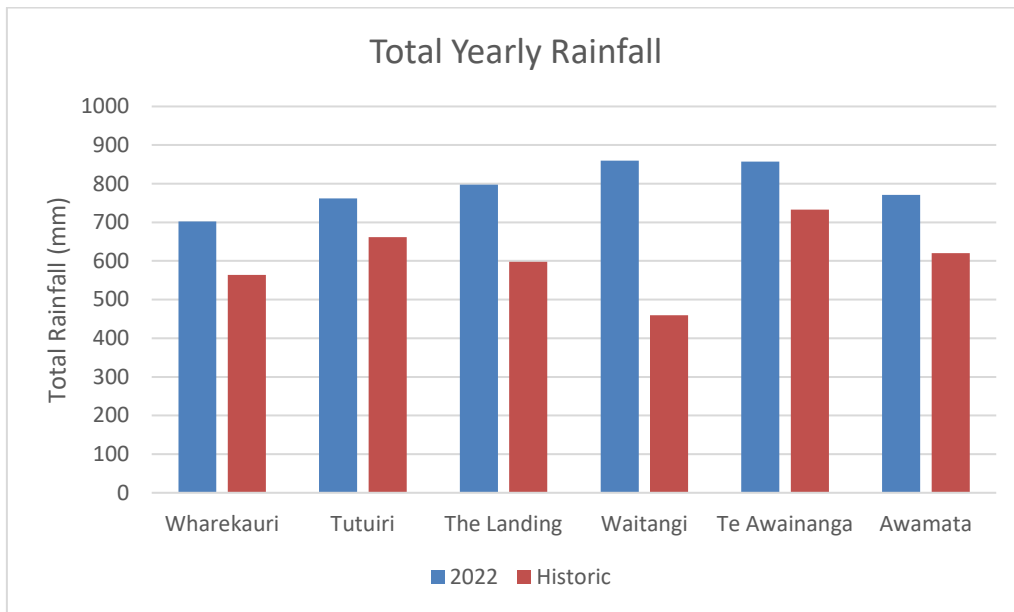
Figure 4-1: Total rainfall for the 2022 hydrological year at the Environment Canterbury rainfall recorders compared to the average total yearly rainfall

The six Environment Canterbury rainfall recorders experienced between 150 – 170 ‘rain days’ over the 2022 hydrological year totalling between 760 – 860 mm of recorded rainfall on the Chatham Islands. All six Environment Canterbury rainfall stations experience more than average rainfall (Figure 4-1). These results are consistent between sites showing that in this “wet” year rainfall days and total rainfall are very consistent across the island (both north to south and east to west). The historic (average data) shows little more variation, but are still well spread across the island.

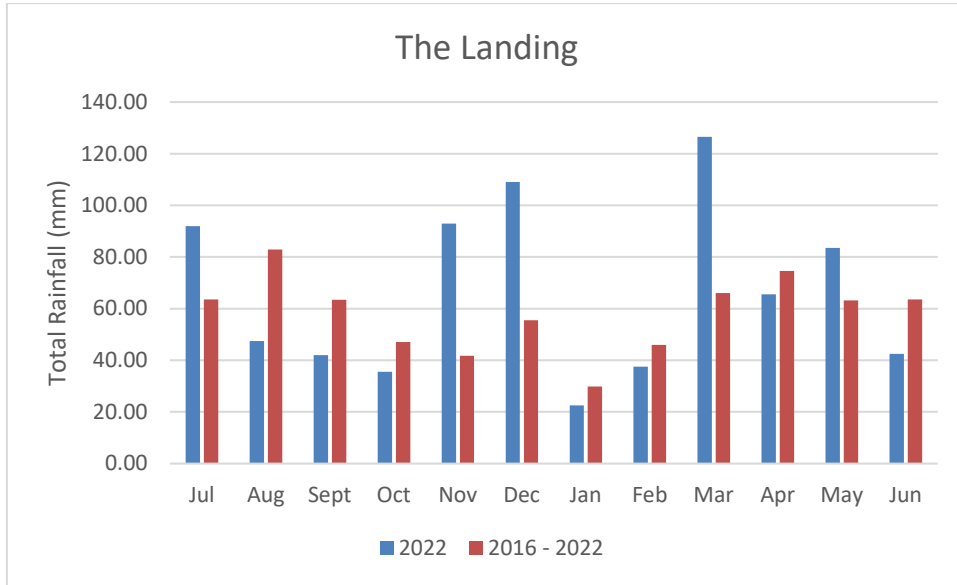
Figure 4-2: Monthly rainfall (mm) for The Landing site through the 2022 hydrological year compared to the long-term record

The Landing rainfall recorder experienced significantly more rain in November, December, and March compared to the long-term record between 2016 and 2022 (Figure 4-2).

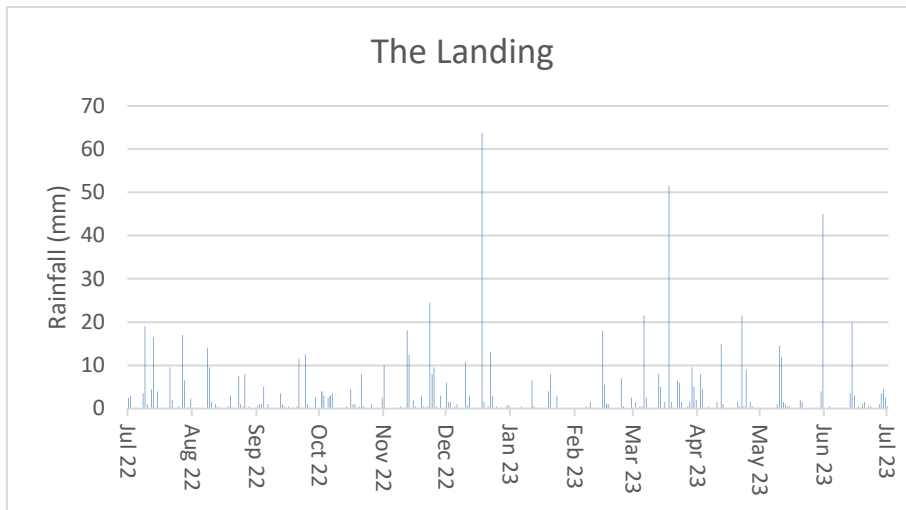
Figure 4-3: Total daily rainfall at The Landing rainfall recorder for the 2022/23 hydrological year

The Landing rainfall station experienced 797.5 mm of rain over the 2022 hydrological year with 157 days of rain. The three days with the most rain was 18 December 2022, 18 March 2023, and 31 May 2023 with 63.8 mm, 51.5 mm, and 45 mm of rain respectively (Figure 4-3).

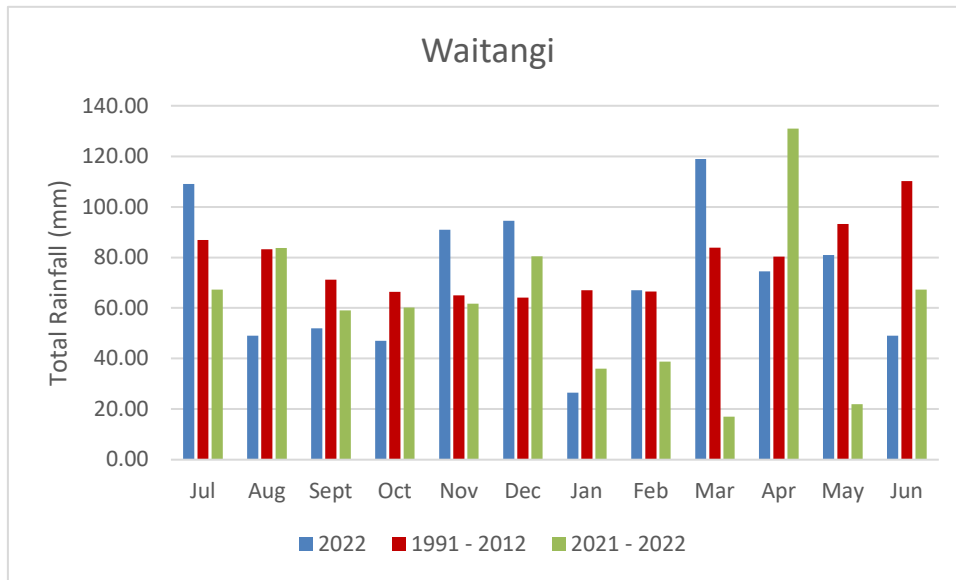
Figure 4-4: Monthly rainfall (mm) for the Waitangi site through the 2022/23 hydrological year compared to the long term record

The Waitangi rainfall station was reinstated in May 2021 to ensure that a long-term record on Chatham Island was maintained, this is due to the historic Waitangi site Chatham Islands Aws, which operated from 1990 to 2012, being decommissioned. The Waitangi rainfall recorder appears to have returned to a more average amount when comparing it to the historic 1991 – 2012 record (Figure 4-4). The 2022/23 hydrological year had more rainfall November, December, and March compared to the time periods from 1991 - 2012 and 2021 - 2022 (Figure 4-4).

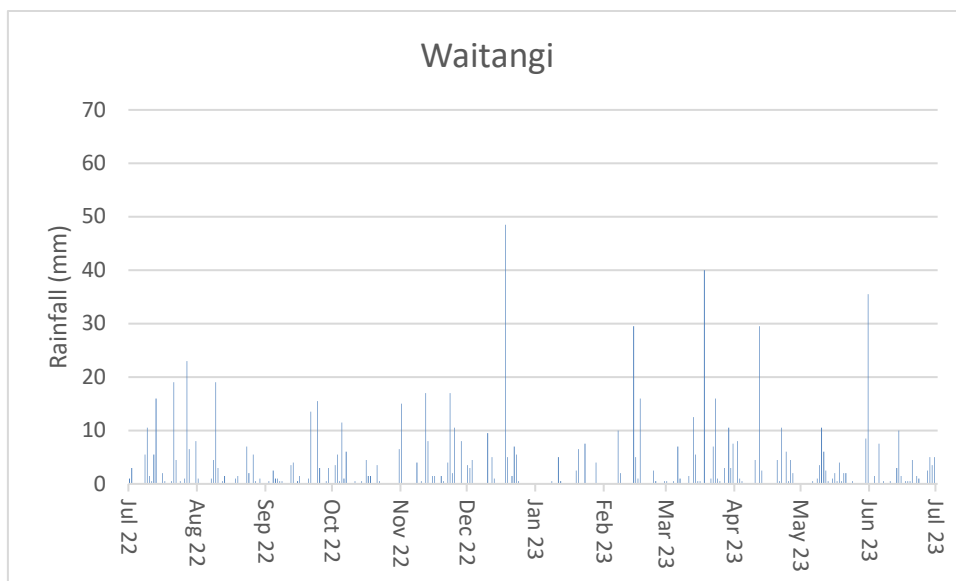
Figure 4-5: Total daily rainfall at the Waitangi recorder for the 2022/23 hydrological year

The Waitangi rainfall station experienced 859.5 mm of rain over the 2022 hydrological year with 170 days that rained, which was the highest number of days and volume of rain on the Chatham Islands for the 2022 hydrological year. The Waitangi rainfall recorded a maximum of 45.5 mm of rain on 18 December 2022 followed by 40 mm on 18 March 2023 (Figure 4-5).

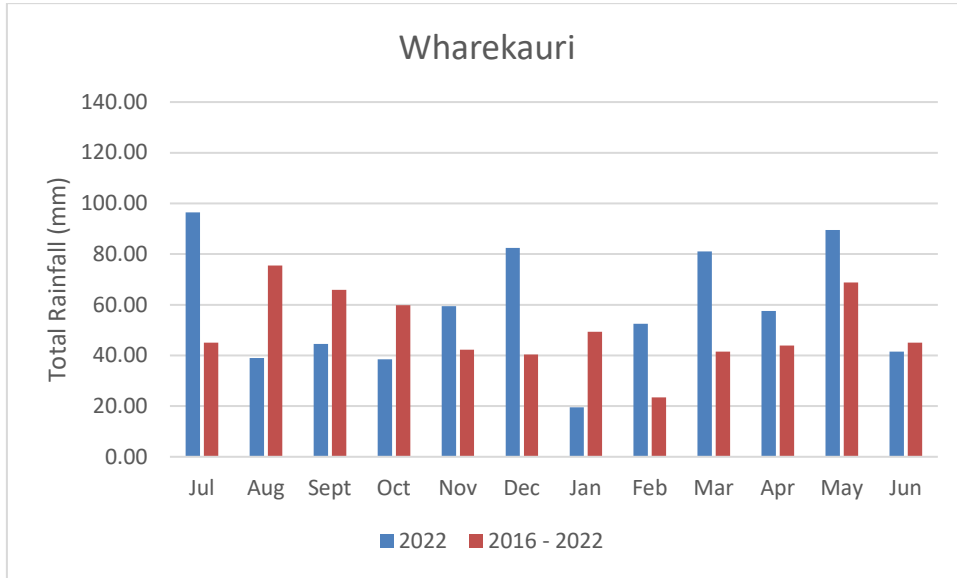
Figure 4-6: Monthly rainfall (mm) for the Wharekauri site through the 2022/23 hydrological year compared to the long-term record

The Wharekauri rainfall recorder had a drier than average August, September, October, and January when compared to the average rainfall per month between 2016 and 2022 (Figure 4-6).

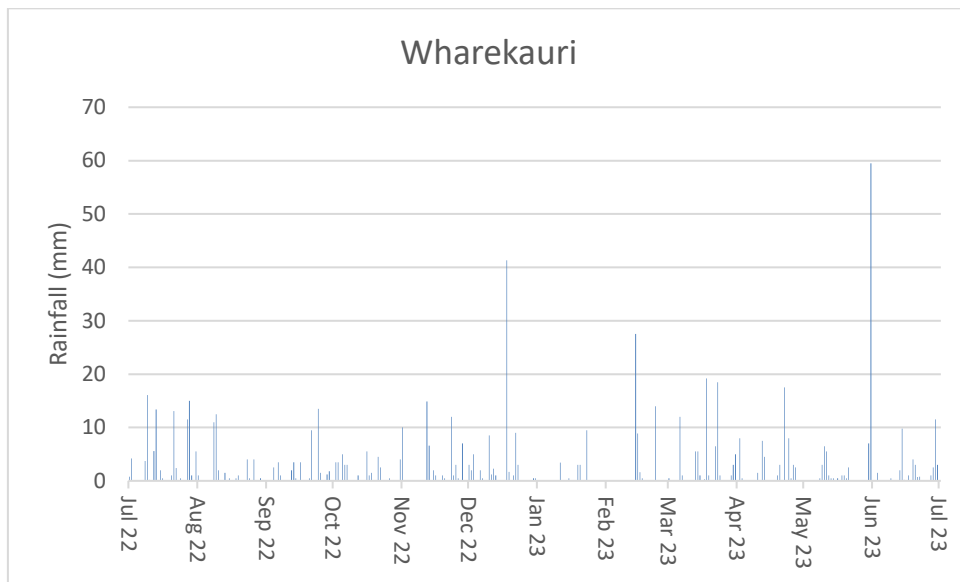
Figure 4-7: Total daily rainfall at the Wharekauri recorder for the 2022/23 hydrological year

The Wharekauri recorder experienced 702 mm of rain over 149 days with 41.3 mm of rain on 18 December 2022 and 59.5 mm of rain on 31 May 2023. These two days of rain accounted for over half of the rain in their respective months (Figure 4-7).

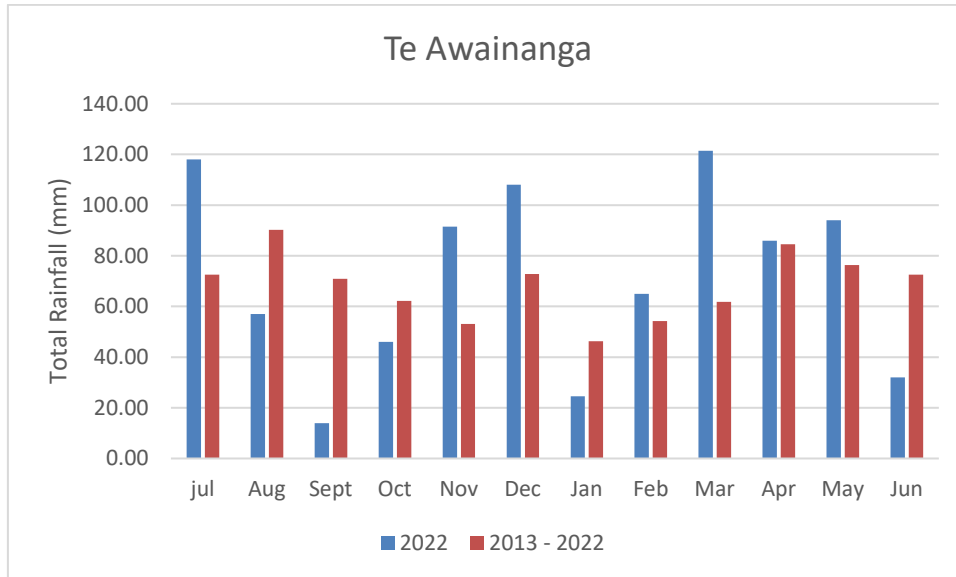
Figure 4-8: Monthly rainfall (mm) for the Te Awainanga site through the 2022 hydrological year compared to the long term record

The Te Awainanga flow recorder has a missing record of 15.5 days between 6 and 22 November 2022 due to an issue with communications. Figure 4-8 and Figure 4-9 contain synthetic data between 2 May 2023 to 20 June 2023 as it was an incomplete period.

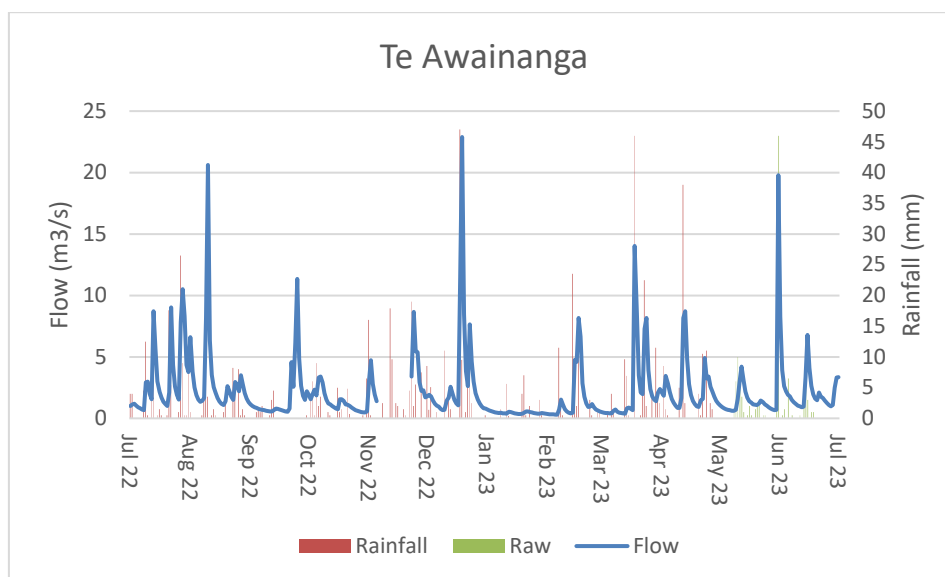
Figure 4-9: Daily mean flow at the Te Awainanga flow recorder over the 2022 hydrological year along with the associated rainfall for the period

The Te Awainanga flow recorder has a 7D MALF (Mean Annual Low Flow) of 0.318 m³/s, a 7D annual low flow for the 2022 hydrological year of 0.328 m³/s, and a minimum recorded flow of 0.3 m³/s (Figure 4-9). The rainfall recorder had a maximum rainfall of 47 mm on 18 December 2022 followed by 46 mm on 18 March 2023 and 31 May 2023.

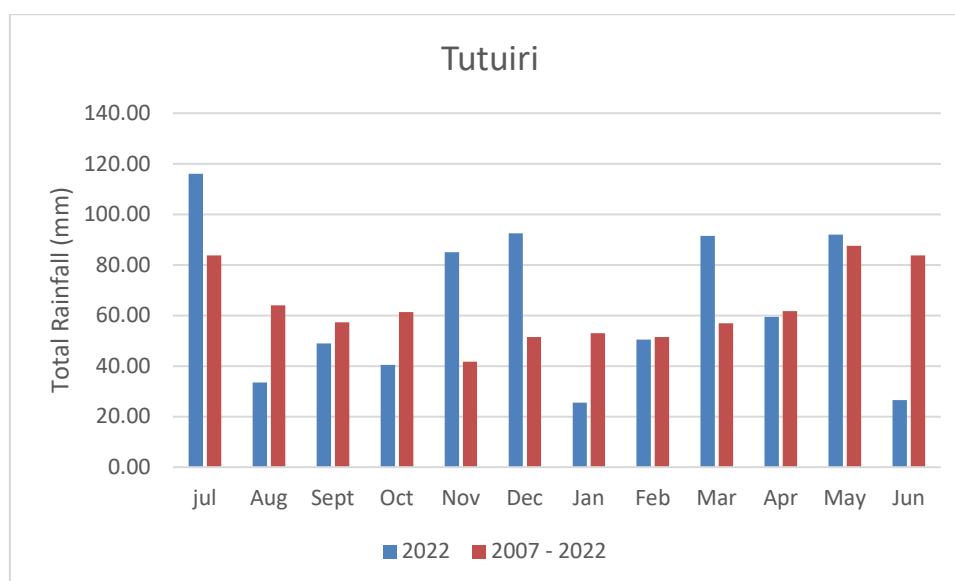
Figure 4-10: Monthly rainfall (mm) for the Tutuiri site through the 2022 hydrological year compared to the long term record

The Tutuiri rainfall recorder illustrated a wetter than average November, December, and March (Figure 4-10).

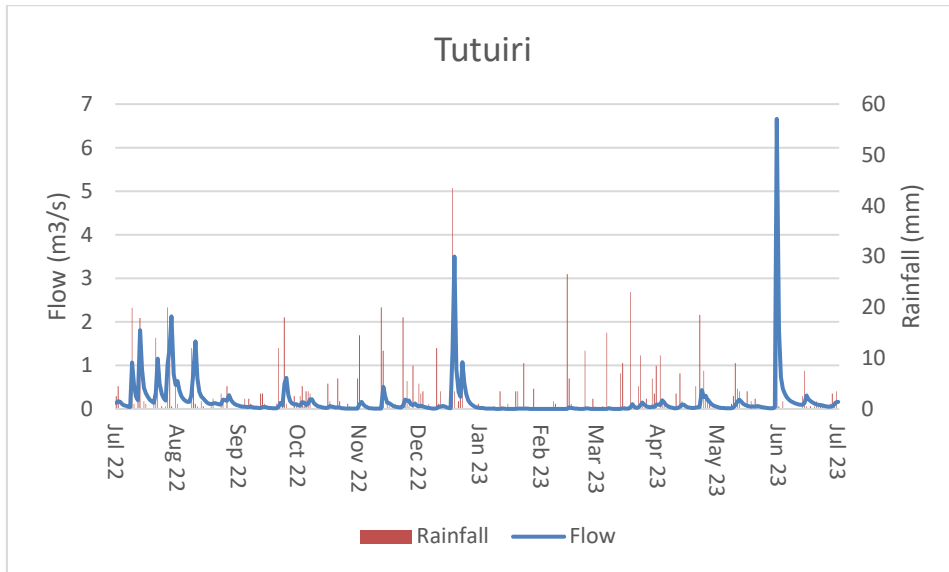
Figure 4-11: Daily mean flow at the Tutuiri flow recorder over the 2022 hydrological year along with the associated rainfall for the period

The Tutuiri flow recorder had an annual low flow of only 0.001 m³/s with a 7D MALF of 0.002 m³/s. The river had a zero minimum flow and therefore experienced dry reaches, however, this has been observed almost every year since 2006 (Figure 4-11). The two largest rainfall events of 43.5 mm of rain on 18 December 2022 and 51 mm rainfall on 31 May 2023 corresponded to the two largest peaks in daily mean flow of 3.5 m³/s and 6.67 m³/s on their corresponding days.

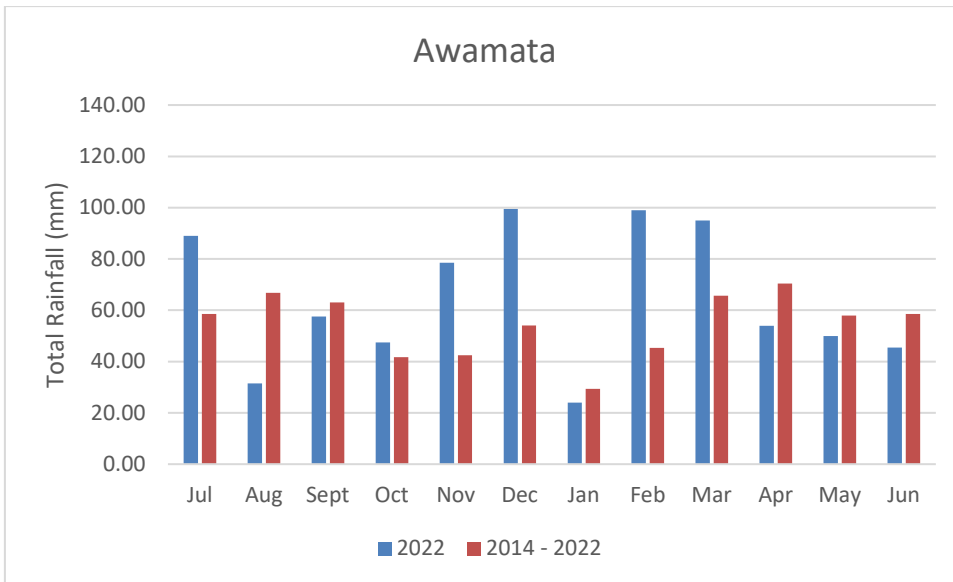
Figure 4-12: Monthly rainfall (mm) for the Awamata site through the 2022 hydrological year compared to the long term record

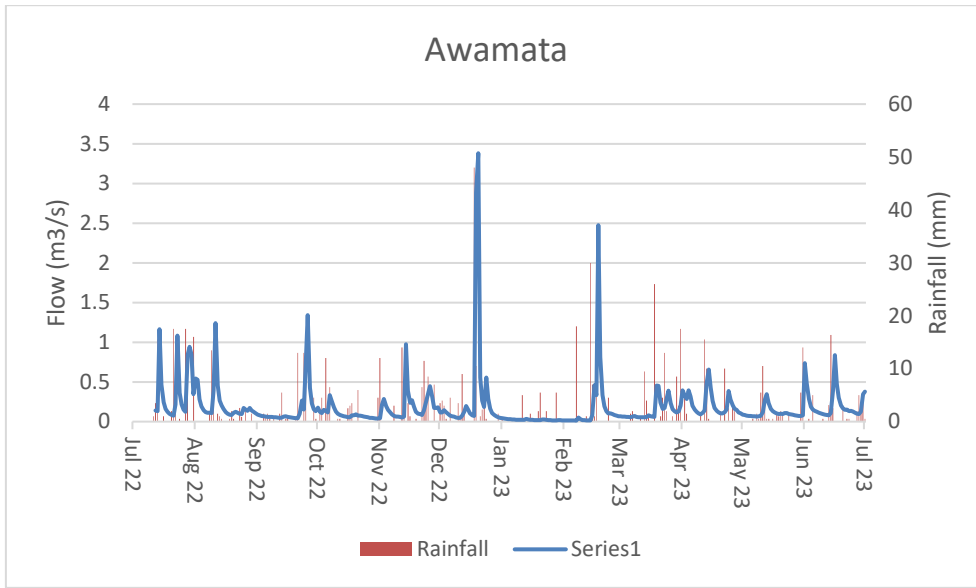
Figure 4-13: Daily mean flow at the Awamata flow recorder over the 2022 hydrological year with the associated rainfall station

The Awamata flow recorder has a missing record from 1 June to 10 June and had a 7D MALF of 0.013 m³/s and a 2022 hydrological year 7D annual low flow of 0.013 m³/s and a minimum recorded flow of 0.01 m³/s (Figure 4-13). The December and March peaks correspond to the largest rainfall events indicated within the rainfall data with flows of 3.38 m³/s and 2.47 m³/s respectively.

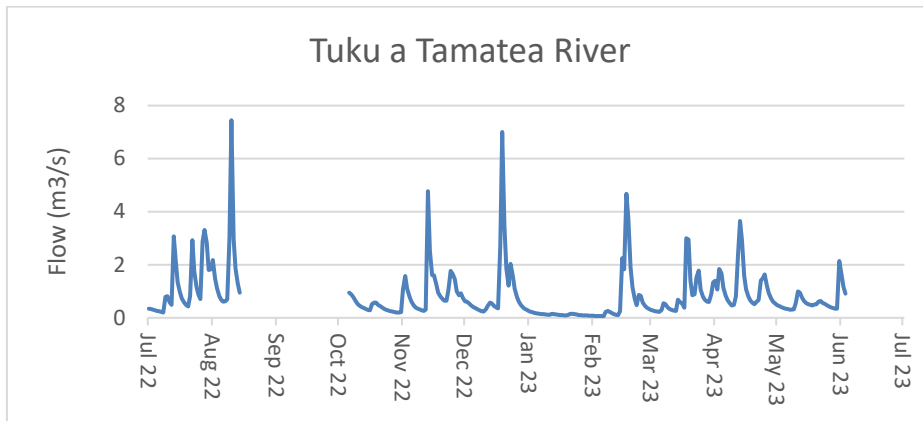
Figure 4-14: Daily mean flow at the Tuku a Tamatea flow recorder over the 2022 hydrological year

Tuku a Tamatea has a missing record of 51.6 days between August to October 2022 and a missing record of 24 days in June 2023 due to a failure of the flow recorder. It had a minimum flow of 0.06 m³/s, an annual low flow of 0.07 m³/s and has a 7D MALF of 0.064 m³/s (Figure 4-14).

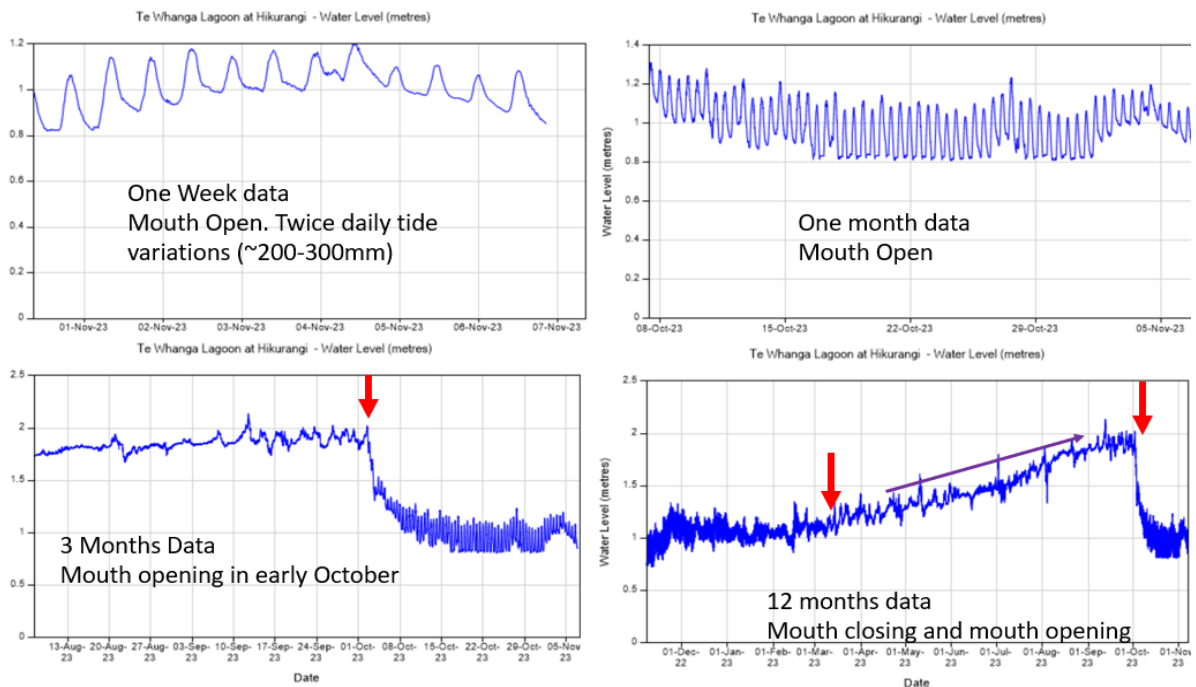
Figure 5-1: Displays of various water level data at Hikurangi channel in 2022/23 illustrating different features of the water level record over different time bases

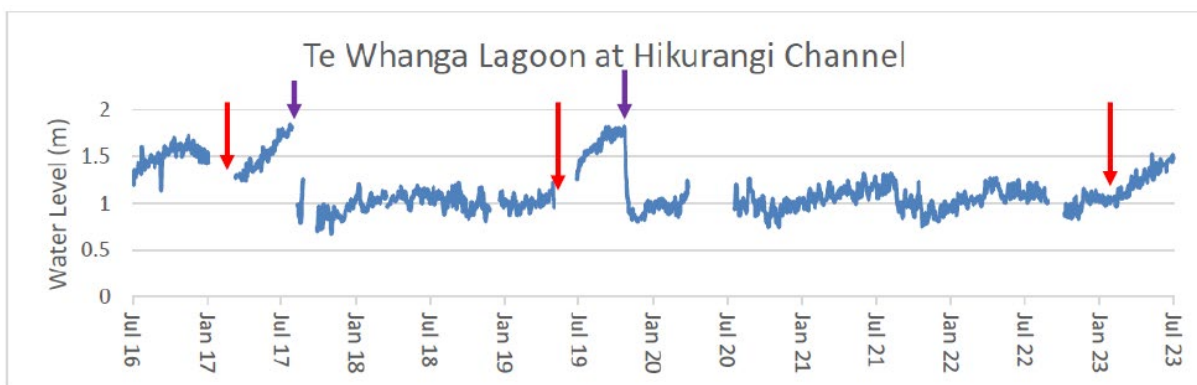
Figure 5-2: Daily average water level in Te Whanga Lagoon at Hikurangi Channel between 2016 and 2022 hydrological years

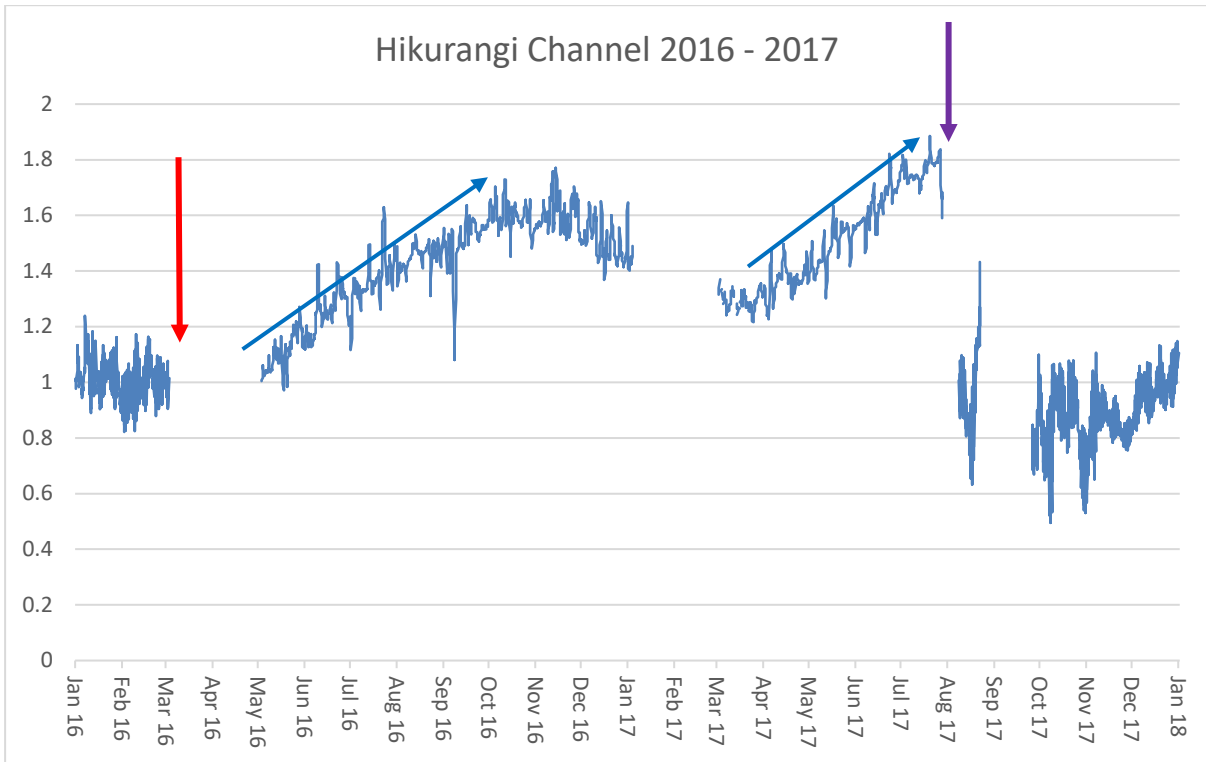
Figure 5-3: 6 hourly mean water level for Hikurangi Channel during 2016 and 2017
 Red arrow indicates approximate mouth closure, purple arrow indicates mouth opening. Blue arrows indicate rates of water level rise.

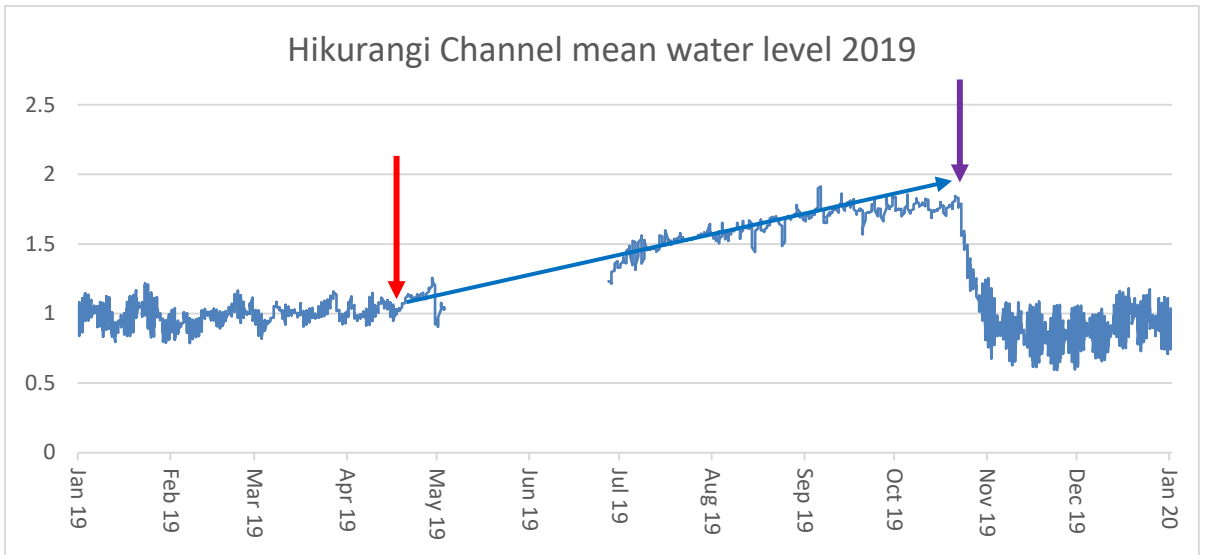
Figure 5-4: 6 hourly average mean water level at Hikurangi Channel for 2019
 Red arrow indicates approximate mouth closure, purple arrow indicates mouth opening. Blue arrow indicates rates of water level rise.

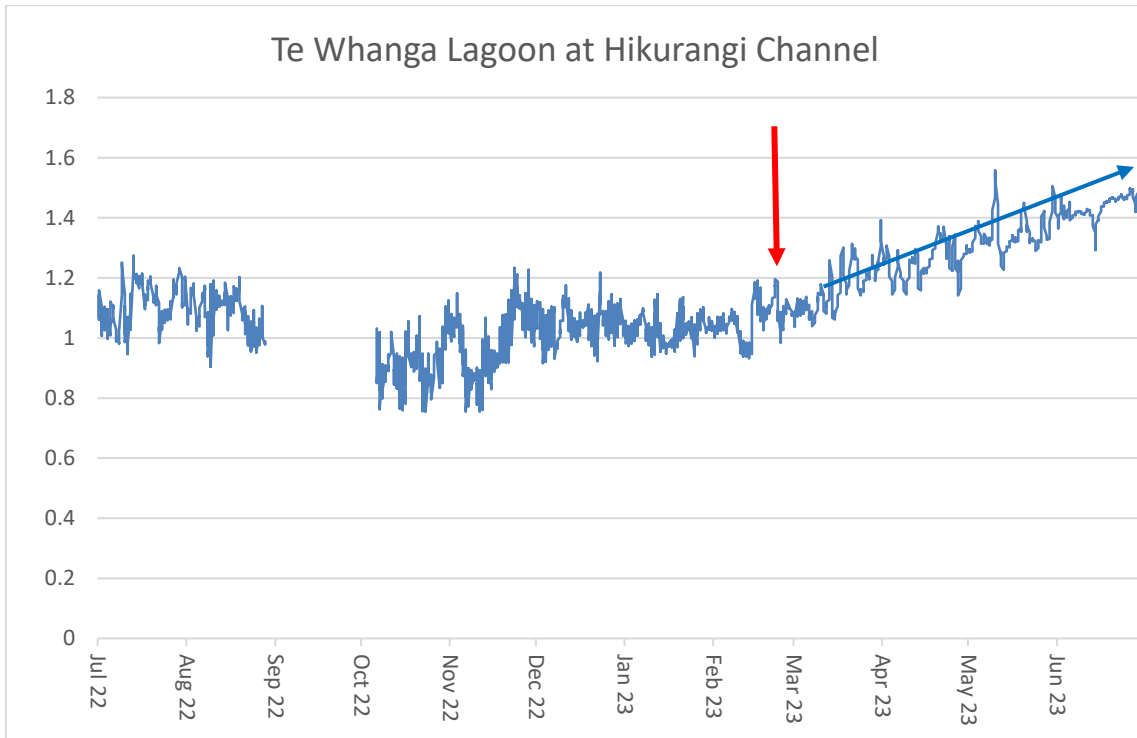
Figure 5-5: 6 hourly mean water level at the Te Whanga Lagoon at Hikurangi Channel water level recorder for the 2022 hydrological year

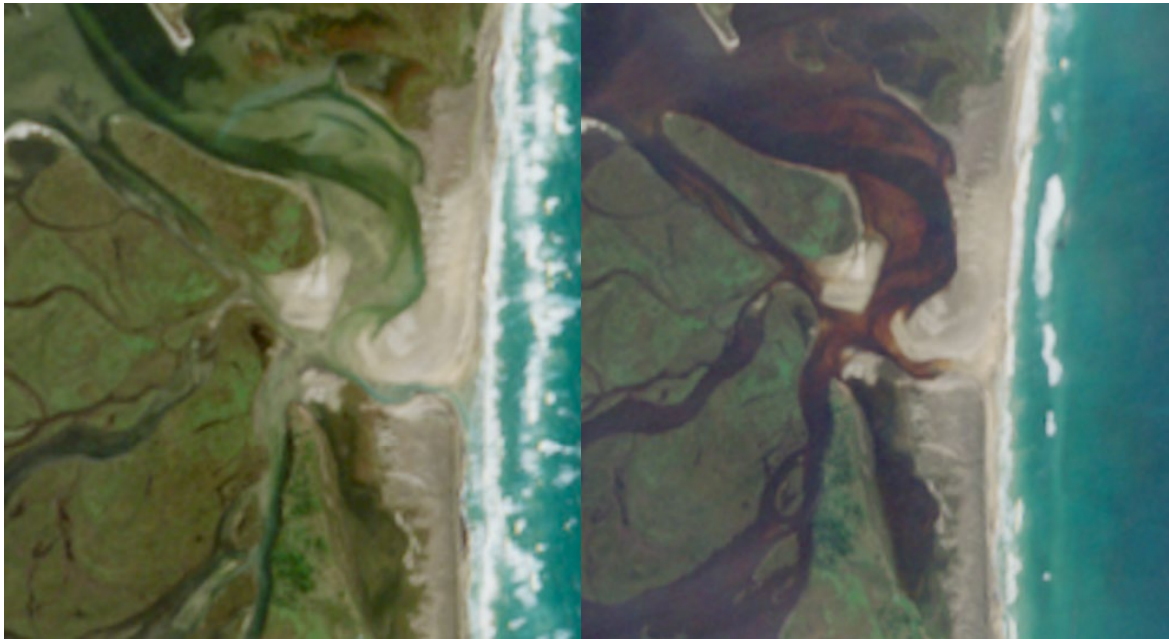
Figure 5-6: Satellite imagery of Hikurangi Channel from Copernicus Sentinel Data 2023 (Copernicus, 2023). Imagery is from 29 March 2023 and 26 April 2023

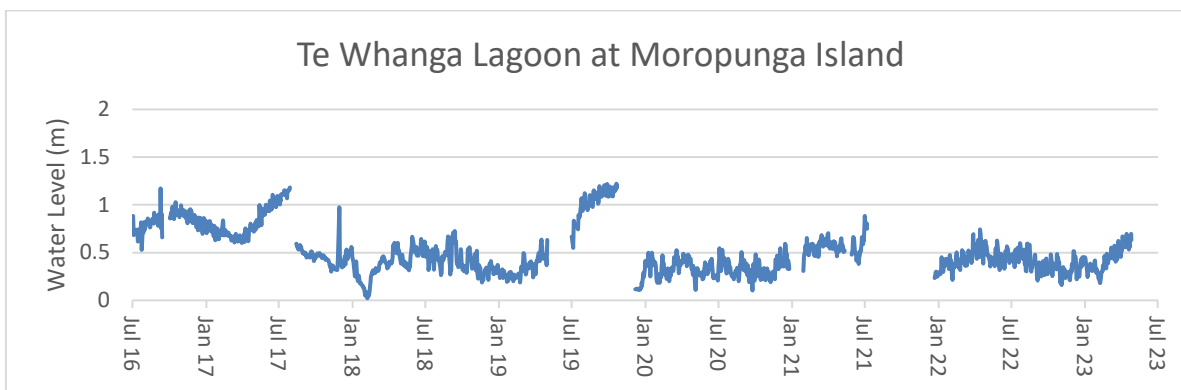
Figure 5-7: Daily average water level at Moropunga Island between 2016 and 2022 hydrological years

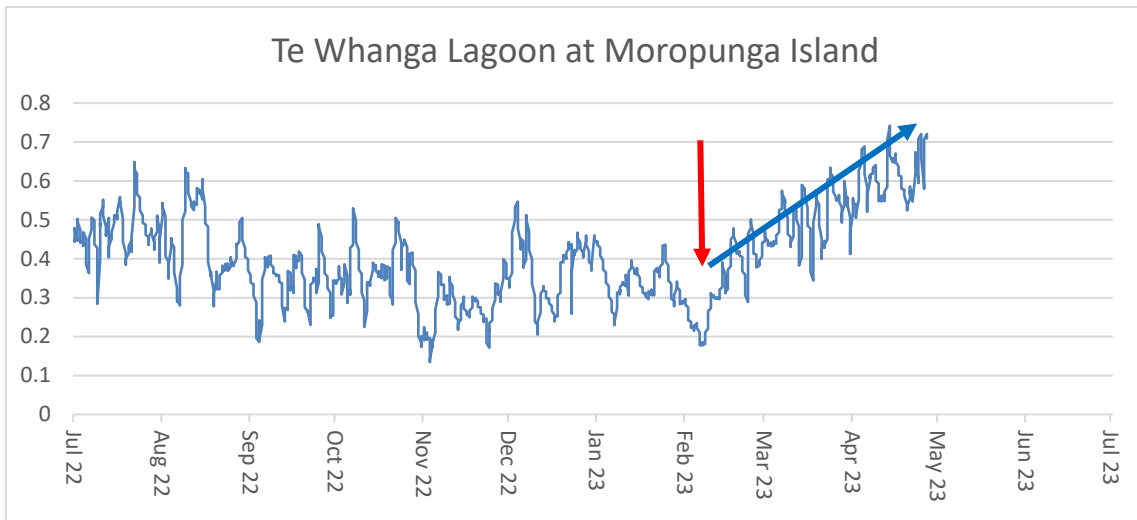
Figure 5-8: 6 hourly mean water level for the Te Whanga Lagoon at Moropunga Island recorder during the 2022 hydrological year. (red arrow indicates lagoon outlet closure)

In more detail, these variation in lagoon water level features are best illustrated in the 2022/23 hydrological year at the Moropunga Island recorder (Figure 5-8). This shows a much higher daily variation in water level often up to 0.4 m rather than the Hikurangi Channel regular tidal variation of 0.2 m and does not exhibit the regular daily “noise” generated by tides. The Moropunga Island recorder data is therefore not as good for identifying or displaying mouth closure and openings but illustrates other important features such as the level variations caused by wind and wave fetch along the axis of the lagoon. These wind driven water level features are also important to fully understand lagoon levels

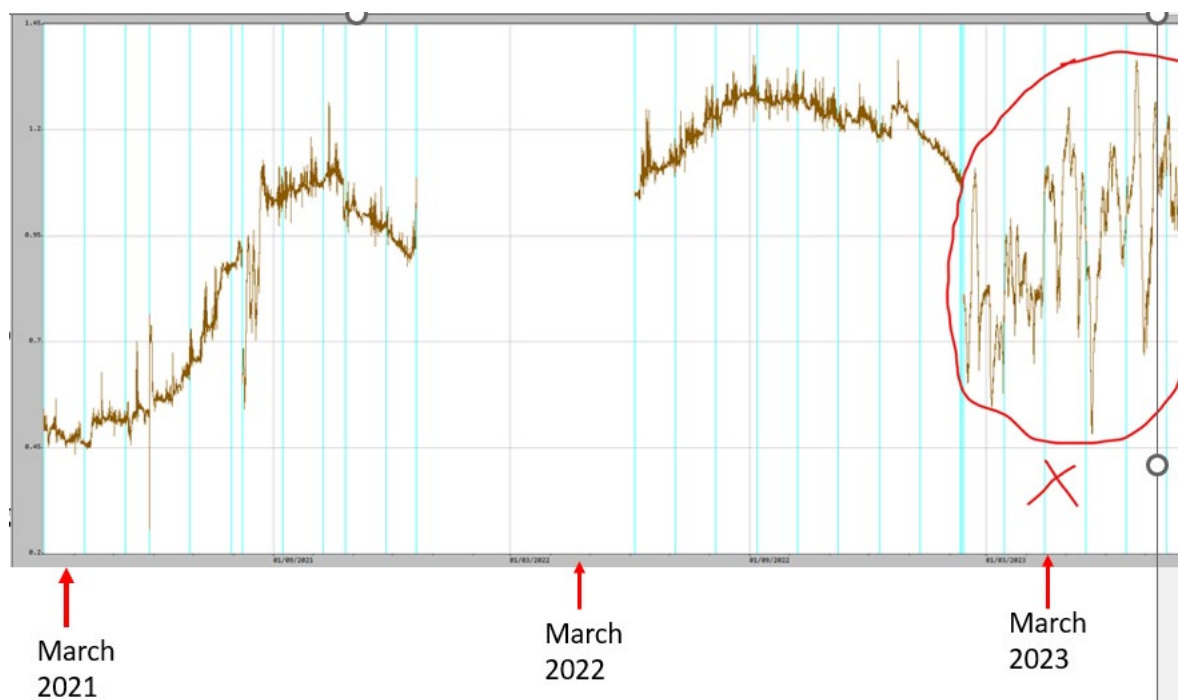
Figure 5-9: Screenshot of raw recorder water level data from Lake Rangitai to illustrate the potential type of data that can be obtained from a highly abstraction exploited lake
